SUMMARY OF ADVISORY BUILDING SAFETY ASSESSMENTS BY INTERNATIONAL ENGINEERS FOLLOWING THE AUG 14 M7.2 HAITI EARTHQUAKE

Report compiled by SARAID UK

25th August 2021

This report summarizes the outcome of detailed building safety evaluations of priority buildings in the Les Cayas area following the M7.2 earthquake that struck the Tiburon Peninsula of Southern Haiti on 14th Aug 2021.

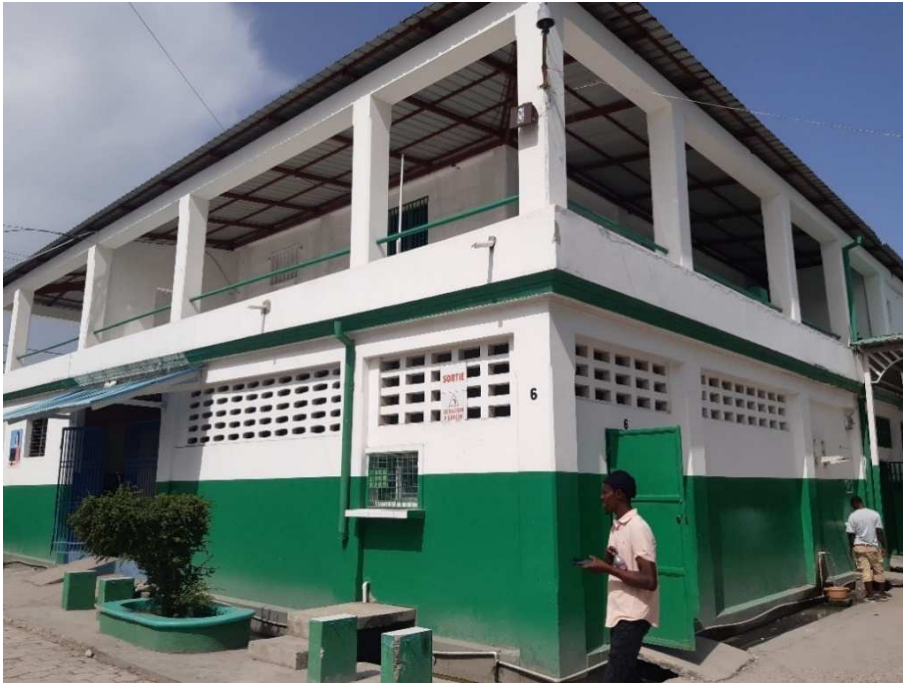
Figure 5 - Building 1

- Damage: There was significant cracking to one of the internal columns. The column was on the left in the room straight ahead of the entrance, as indicated in Figure 6.
- Assessment constraints: We were unable to access any of the upstairs floor and large parts of the ground floor.
- **Recommended restrictions:** Access to the room with the damaged column (it appeared to be an operating theatre) should be prohibited, including the area that is above this room.

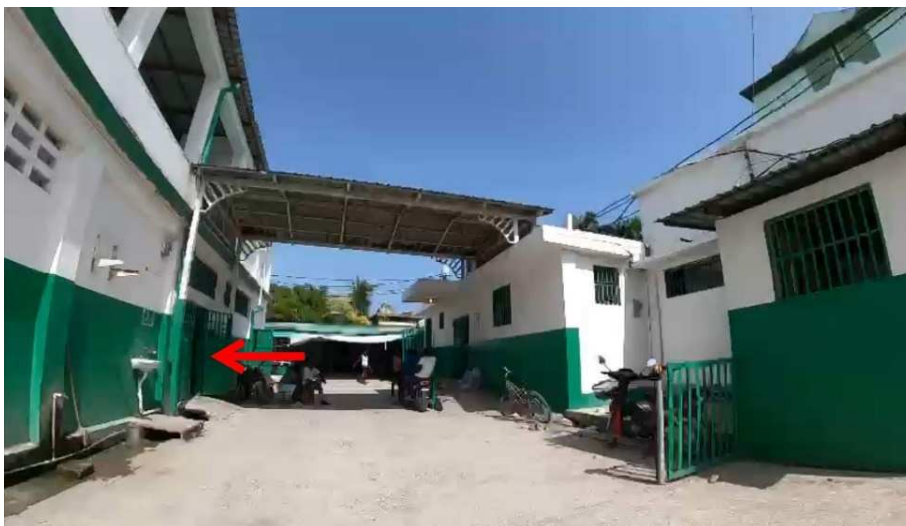
Figure 6 - Access into the room with a damaged column is indicated by the red arrow.

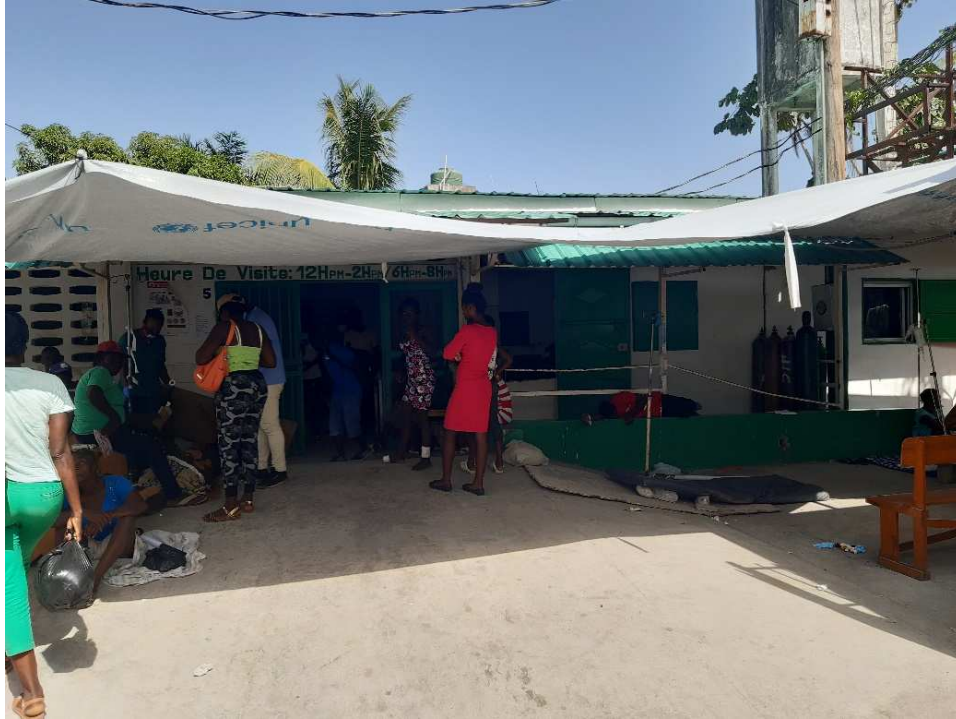
Figure 7 - Building 2

- Damage: There was some cracking to the right of the entrance, but this was deemed to be affecting non-structural elements.
- Recommended restrictions: None

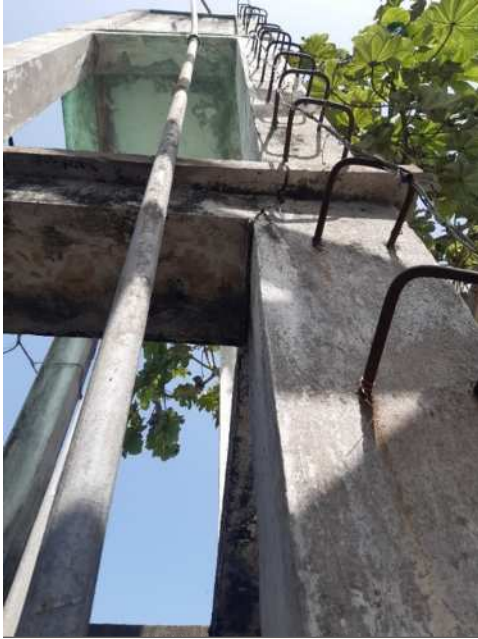
Figure 8 - Building 3, concrete water tower

- Damage: Cracking was observed between most of the beam and column joints. There was also spalling on some of the concrete beams although its assumed, due to the condition of the rebar, this was historic damage
- **Recommended restrictions:** Cordon off the damaged water tower to a distance of 1.5 times the height of the tower area

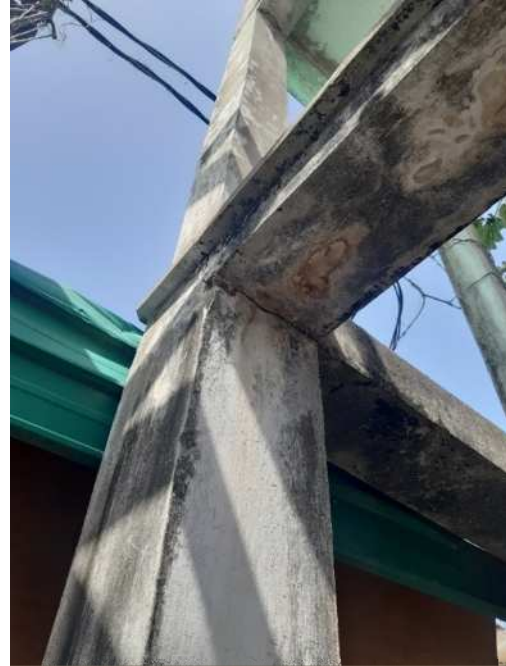
Figure 9 - Cracking between the beam and column joints

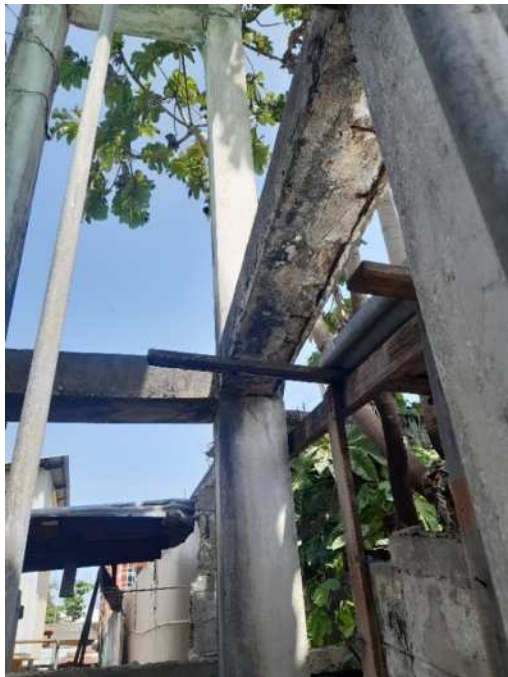
Figure 10 - Spalling of the concrete on the beam

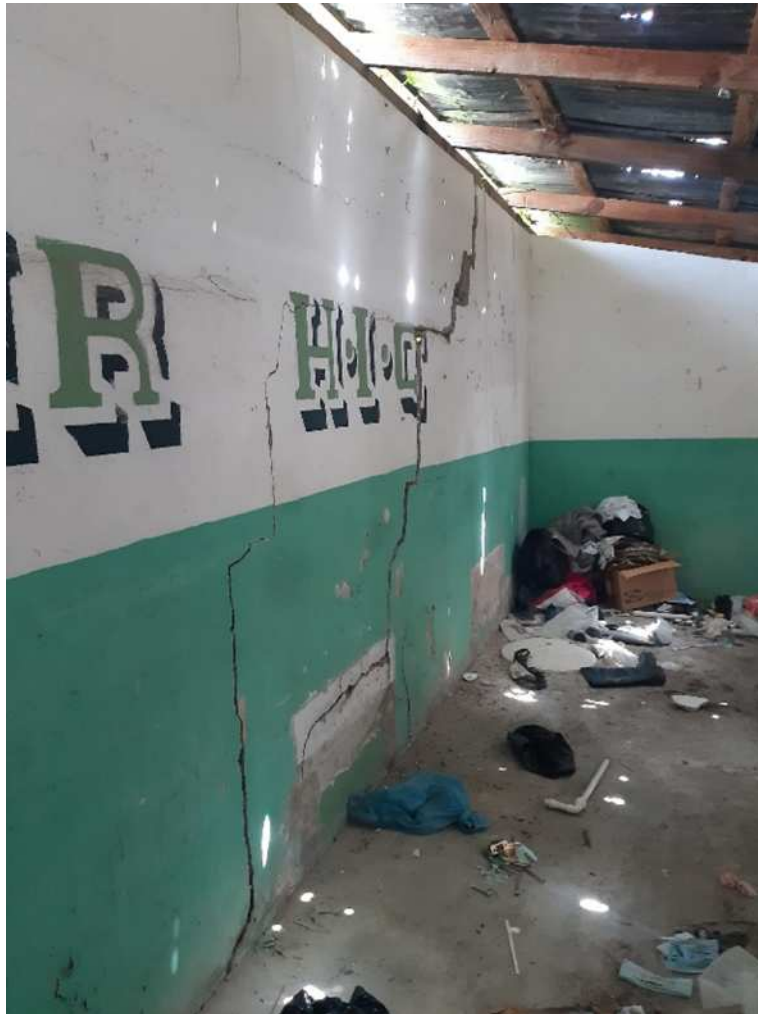
- Damage: Large cracks were observed in the rear wall
- **Recommended restrictions:** Our recommendation is that the building is unsafe to use

Figure 11 - Building 4, cracks in the rear wall

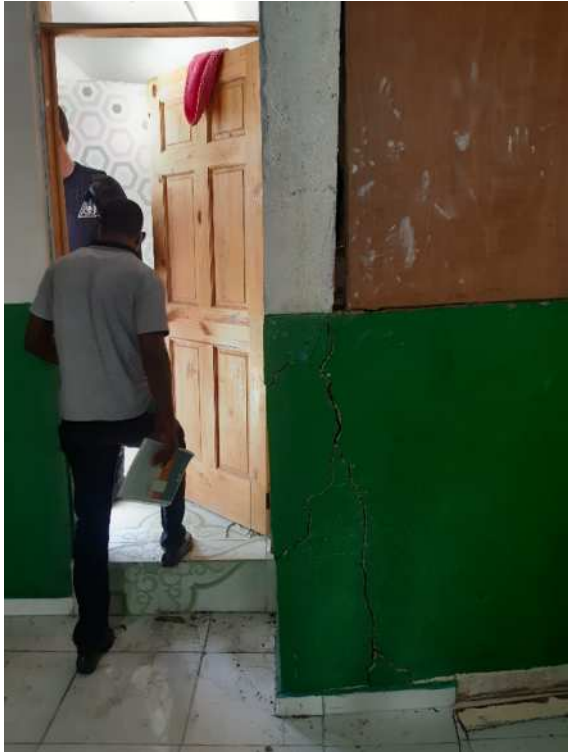
- Damage: The wall next to the rear doorway has some cracking and was leaning.
- Recommended restrictions: Access through the rear entrance should be restricted, and this end of the building should be cordoned off.

Figure 14 - Cracking observed on the opposite side of the wall shown above

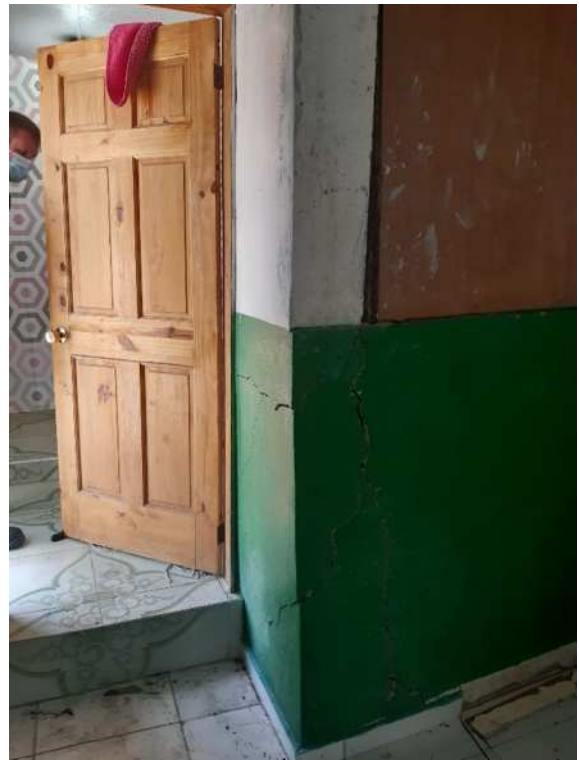
Figure 13 - Cracked and leaning wall in Building 5

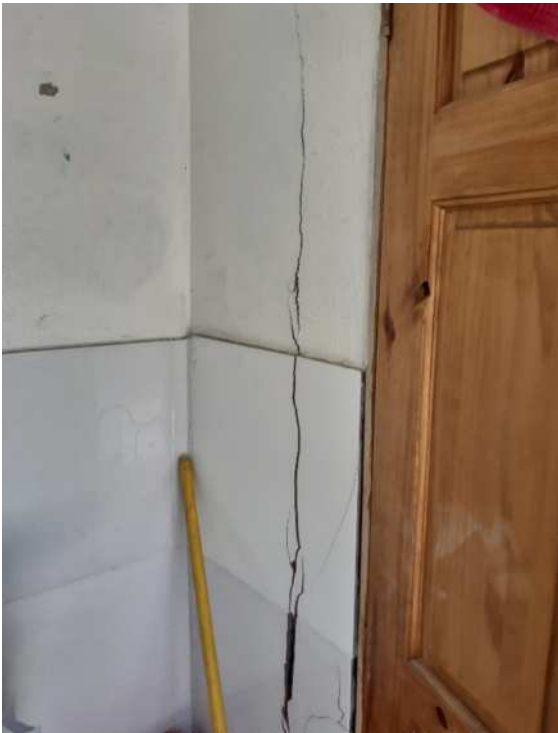
Figure 12 - Cracked and leaning wall in Building 5

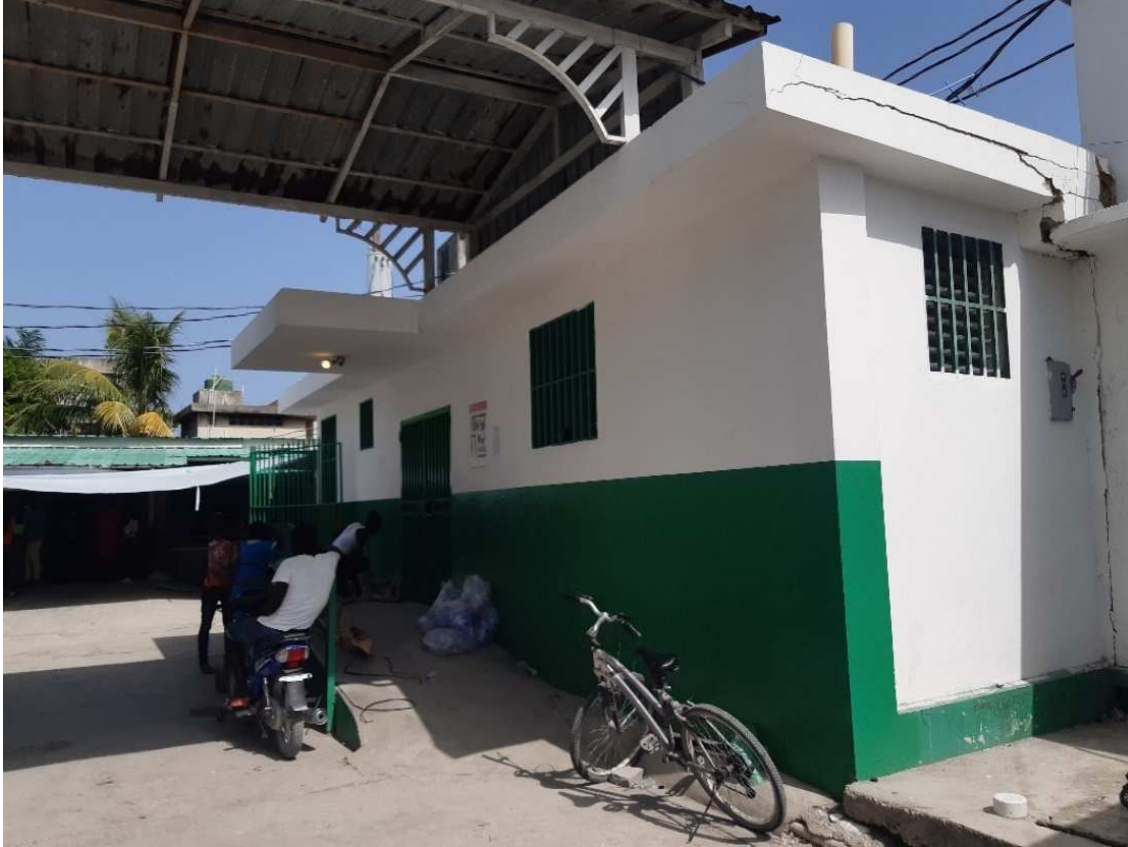
- Damage: Cracking was observed on the external edge of the roof slab, shown in Figure 15 below
- Assessment constraints: The rear of the building, behind the first set of rooms could not be accessed
- Recommended restriction: Cordon off the external area around the cracked beam

Figure 15 - Building 6, image shows cracking to the external edge of the roof slab

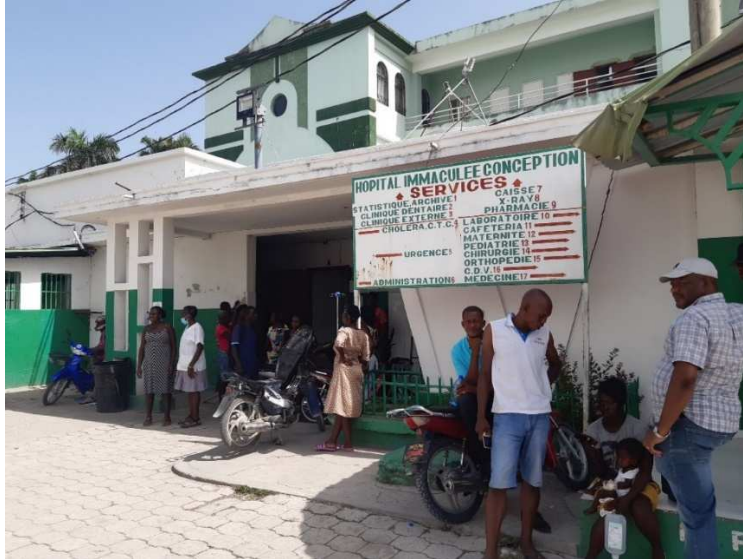
Figure 16 - Building 7

- Damage: Cracking through a beam that is supporting the floor above. Cracking present where the beam changes depth.
- Assessment constraints: We were unable to access any of the upstairs floor. The rear of the building, behind the first set of rooms could not be accessed
- **Recommended restrictions:** Our recommendation is that the building is unsafe to use

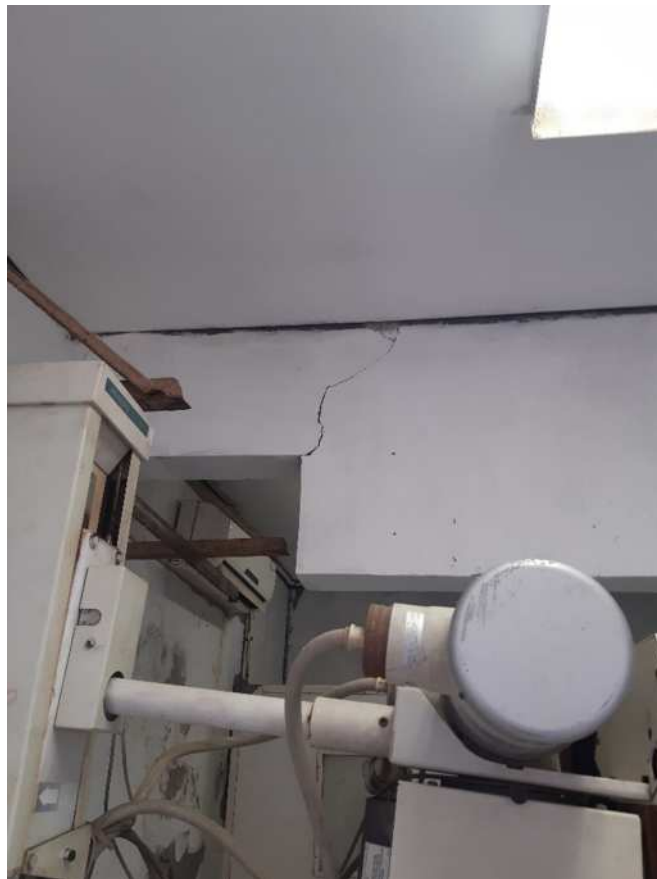
Figure 17 - Cracking of the supporting beam

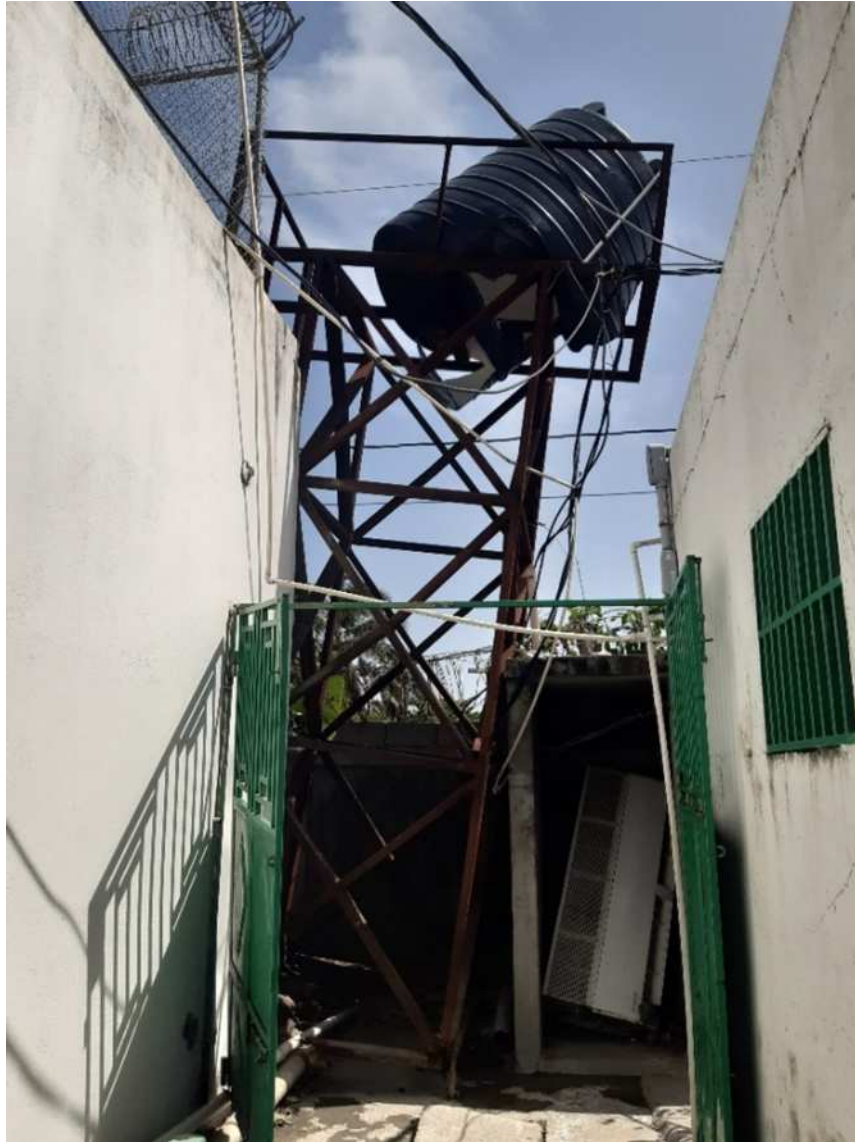
Figure 20 - Building 10

- Damage: The tower was significantly leaning which has displaced the water butt which is no longer secure.
- Recommended restrictions: Cordon off the damaged water tower at a distance of 1.5 times the height of the tower area

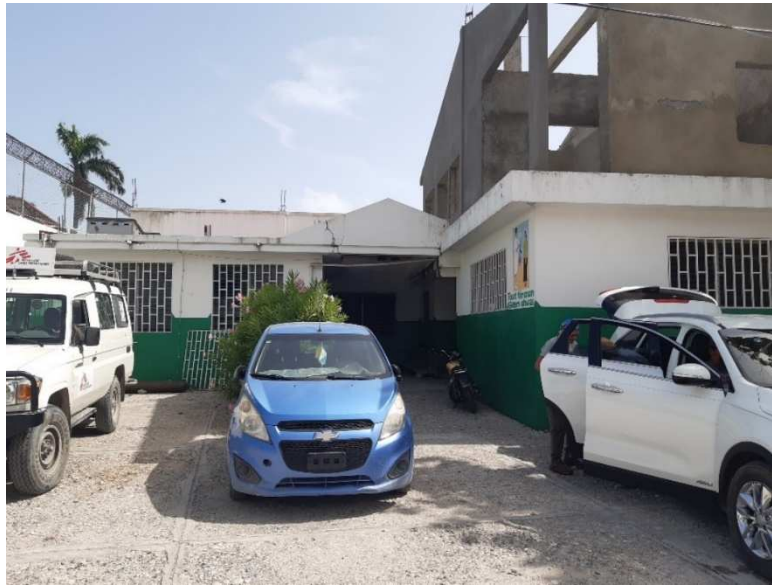
Figure 21 - Building 11

- Damage: A significant crack is present on the entrance arch causing it to be structurally unsafe (see Figure 22). A crack in a supporting beam (see Figure 23). Damage to an external wall that is supported a steel trussed roof. Damage to lintels.
- **Recommended restrictions: Our recommendation is that the building is unsafe to use**

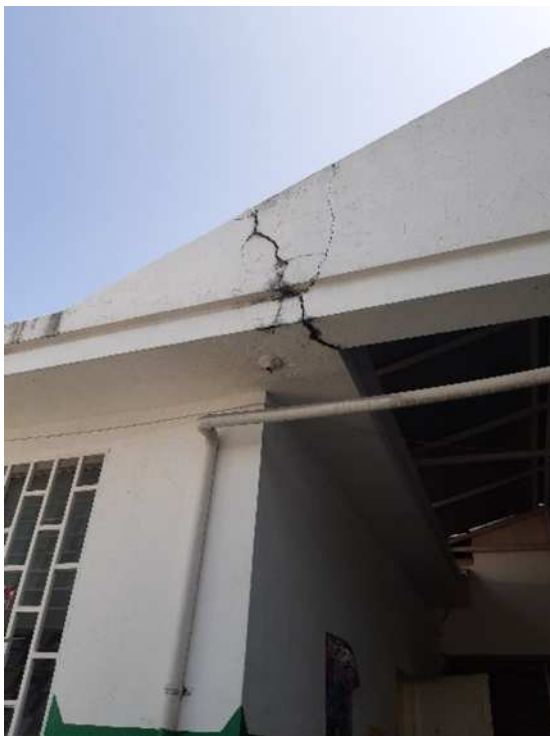
Figure 22 - Crack in the entrance arch

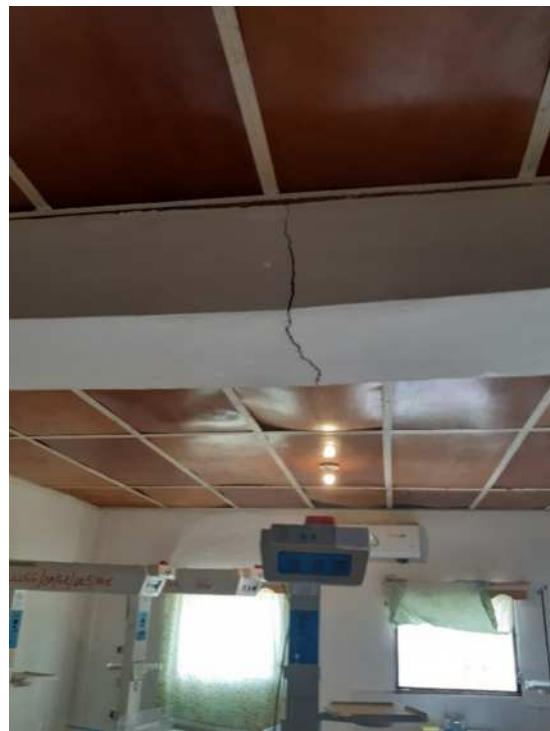
Figure 23 - Crack in a supporting beam

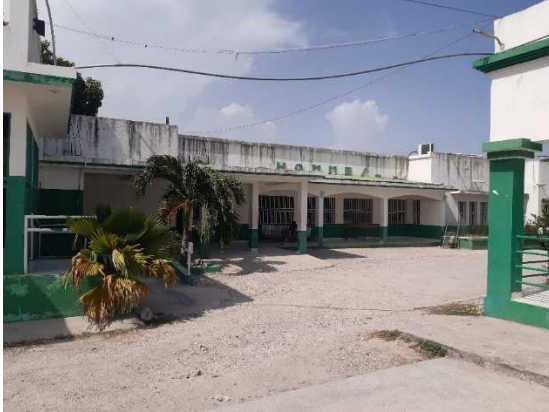
Figure 25 - Building 13

- Damage: The supporting structure to the edge of the entrance overhang was cracked and leaning, see Figure 27.
- Assessment constraints: The area shown in Figure 26 was not accessed.
- **Recommended restrictions:** We advise that the area under the right-hand side of the portico (when looking at the building, Figure 27) should be restricted.

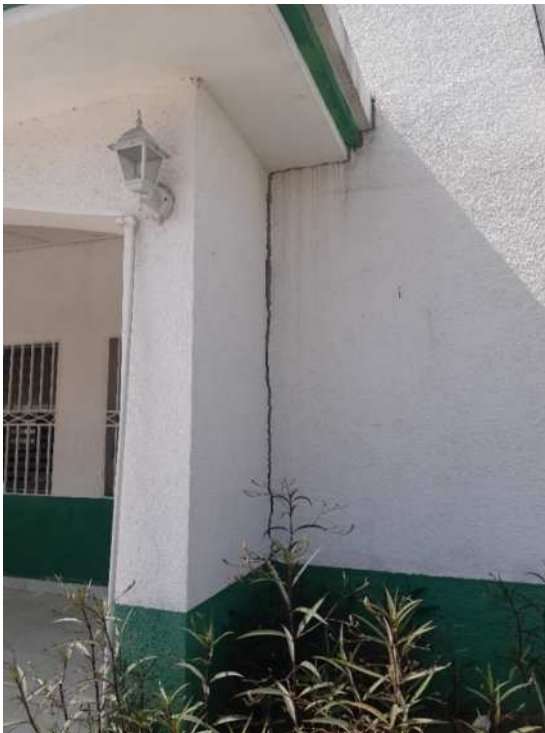
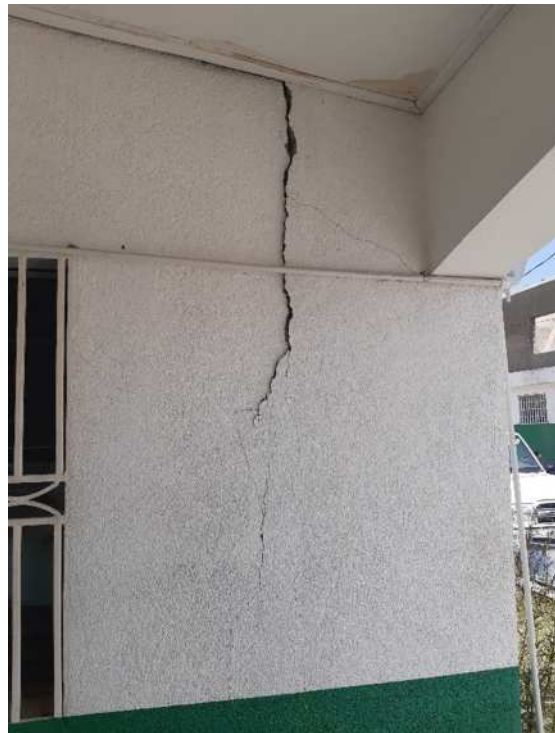
Figure 27 - Crack on the supporting structure of the portico

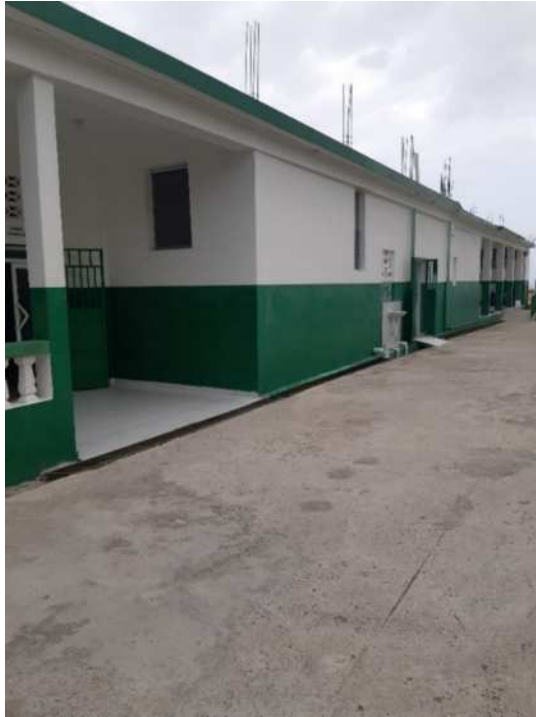
Figure 29 - Building 15

- Damage: Minor cracking to external infill walls, deemed as non-structural damage. Cracking was observed along a movement joint. The structures either side had moved separately from on another and although looks like a significant crack it does not effect the structural integrity of the building.
- **Recommended restrictions: None required**

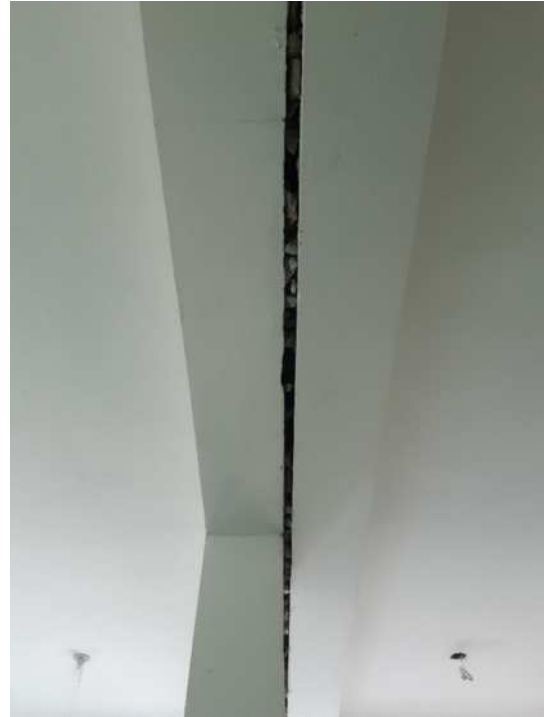
Figure 30 - Cracking along the movement joint in building 15

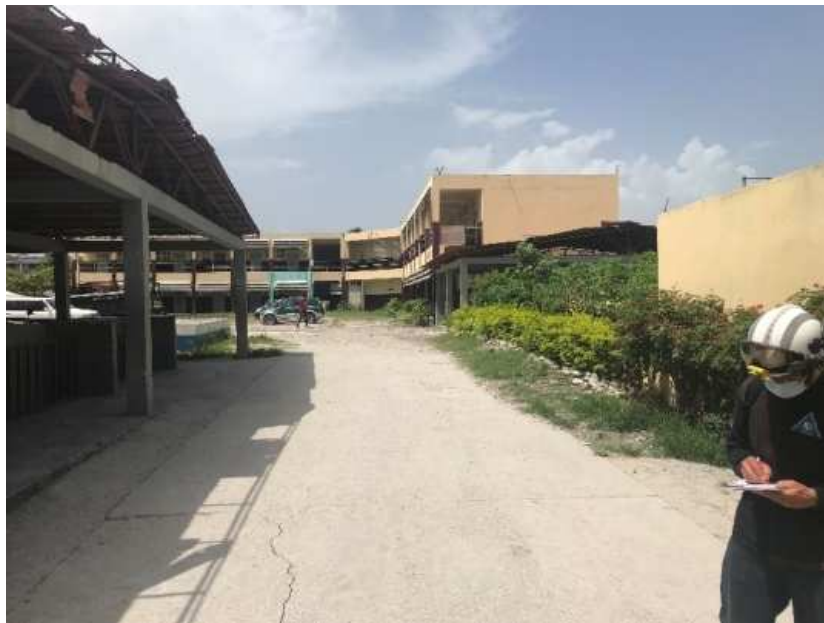
Figure 33 - Building 19

- Damage: With the exception of the junction between legs of the southern classroom block the building is undamaged and users can move readily throughout the premises. At the junction of the building's legs there is an infill section, comprising a reinforced concrete walkway, where relative displacement has resulted in a slight gap at either side. Users can negotiate this without risk.
- **Recommended restrictions: None required**

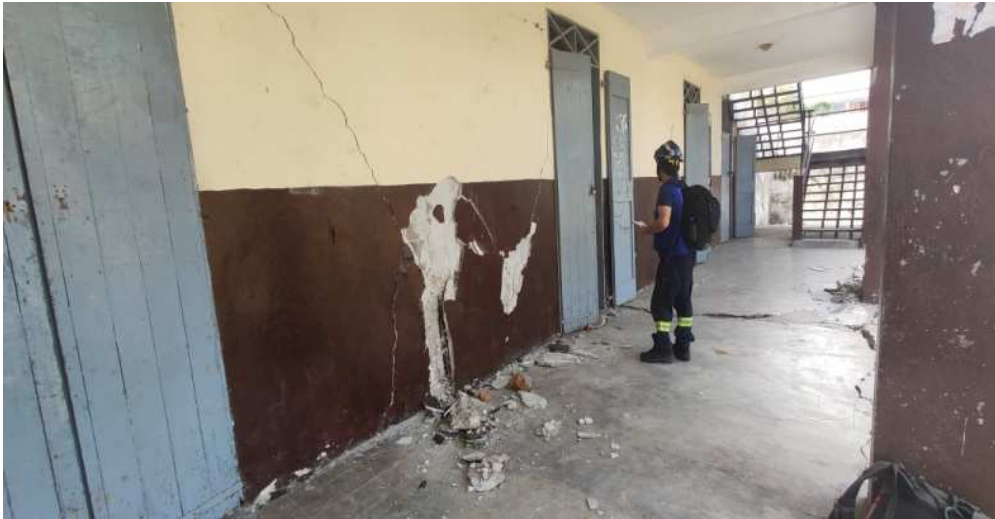
Figure 34 – Building 20

- Damage: The North-East end of this classroom block exhibits structural cracking that is detrimental to the safe use of the facility In the quadrangle between the classroom blocks there is a UNICEF tent which local residents are using as a safe refuge. This is sufficiently distant from the buildings to avoid hazards associated with further seismic events.
- **Recommended restrictions- Access to the building to be restricted until a detailed evaluation confirms whether it is safe for use or needs to be evacuated.**

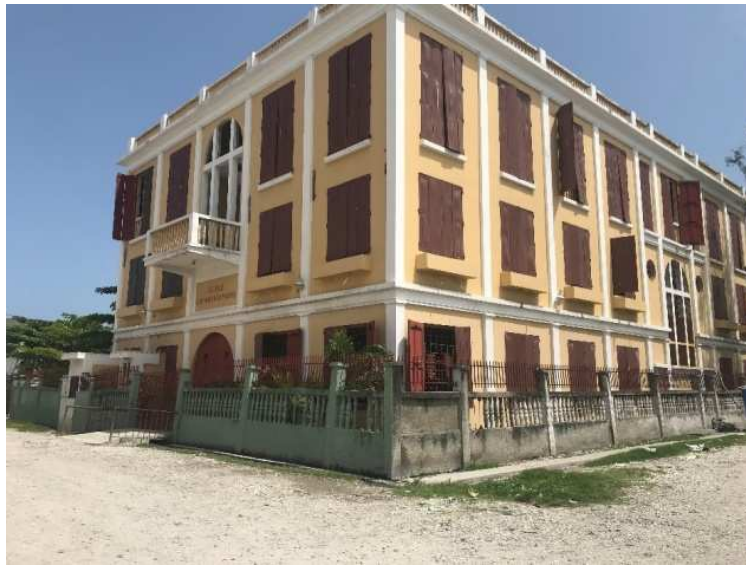
Figure 36 - Building 21

- Damage: The rectangular classroom block encloses a paved courtyard where it is evident that the ground surface has risen significantly above its original level. Also it appears that the building level has dropped relative to the adjacent pavement. Some ponding of surface water around the building reflects these changes. The degree of “ground heave” internally raises concern regarding potential for voiding below the surface that could represent a hazard to users or to circumstances associated with redressing the level differentials. In the south eastern part of the building there is some significant structural cracking of ground floor walls and this appears to relate to the ground movement.
- **Recommended restrictions: Access to the building to be restricted until a detailed evaluation confirms whether it is safe for use or needs to be evacuated.**

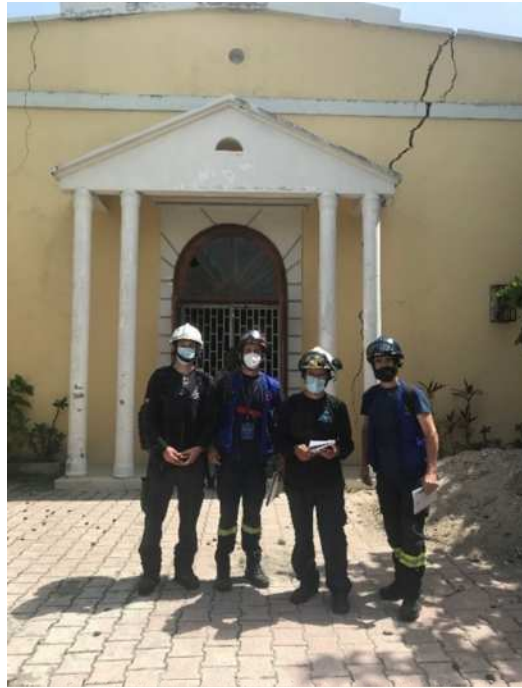
- Damage: There is significant cracking evident externally at the east facade and extensive further structural cracking that is most readily observed from inside the “auditorium” building. The “ground heave” of the building’s paved floor appears to correspond with cracking in the walls. The degree of structural cracking of this building renders it hazardous to people in its vicinity and potentially vulnerable to failure in the event of further seismic effects.
- **Recommended restrictions: Our recommendation is that the building is unsafe to use.**

Figure 38 – Building 22 structural cracking visible at the East facade

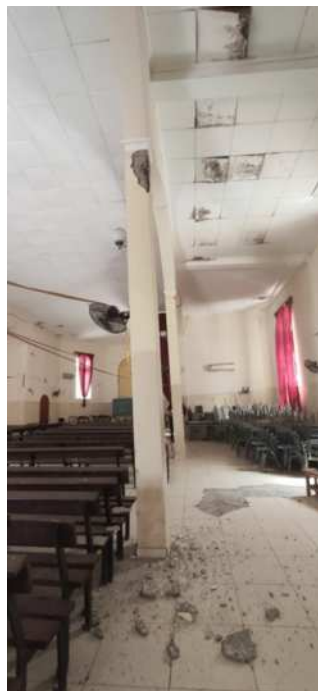
Figure 39 - Extensive structural cracking observed from inside the “auditorium” building

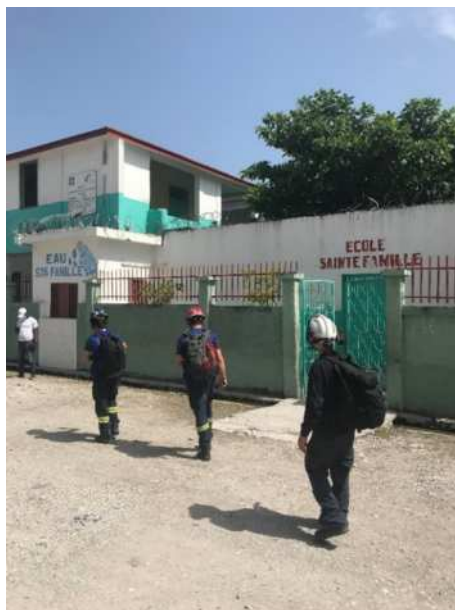
Figure 41 - Building 24

- Damage: This building exhibits areas of varied cracking that are insufficient to suggest that the building structure is compromised. However the presence of the adjacent, and significantly damaged, “auditorium” building should be regarded as a considerable hazard.
- **Recommended restrictions: Access to the building to be restricted until a detailed evaluation confirms whether it is safe for use or needs to be evacuated.**

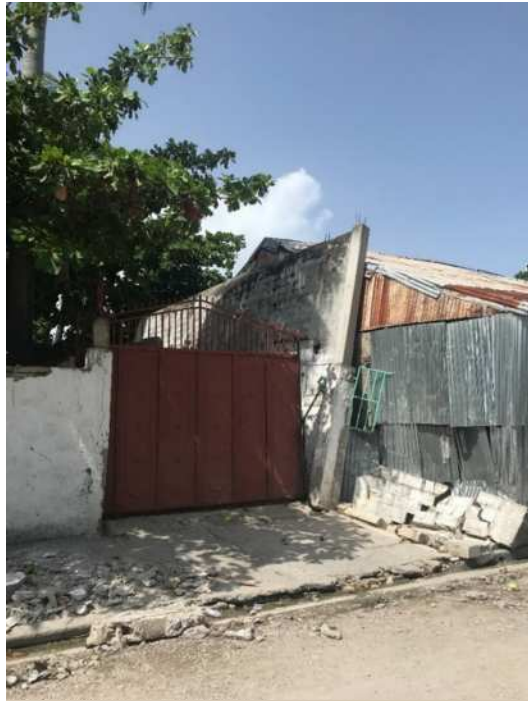
- Damage: The administration building itself is found to be free from any significant damage. However the property's 7m high southern boundary wall has failed by rotating at its base and is only prevented from collapse by leaning against the neighbouring property. This adjacent property is inhabited and the current circumstances are unsafe and very unsatisfactory.
- **Recommended restrictions: Access to the neighbouring building to be restricted until a detailed evaluation confirms whether it is safe for use or needs to be evacuated.**

Figure 42- Building 25 boundary wall

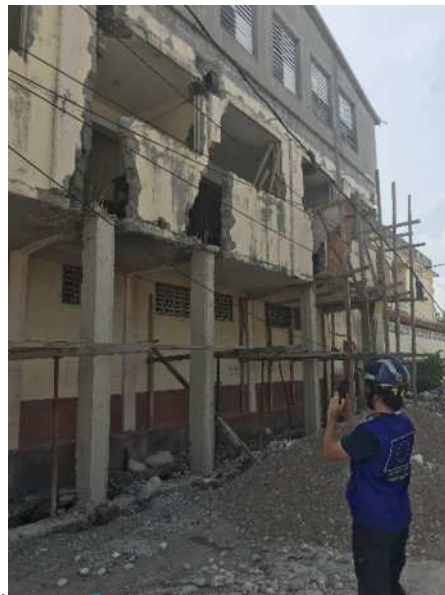
Figure 45 - Building 28

- Damage: The FIC college building, seen beyond the scaffolded structure, may need to have structural repairs subject to the outcome of further inspection when access can be arranged.
- Recommended restrictions: Access to the building to be restricted until a detailed evaluation confirms whether it is safe for use or needs to be evacuated.

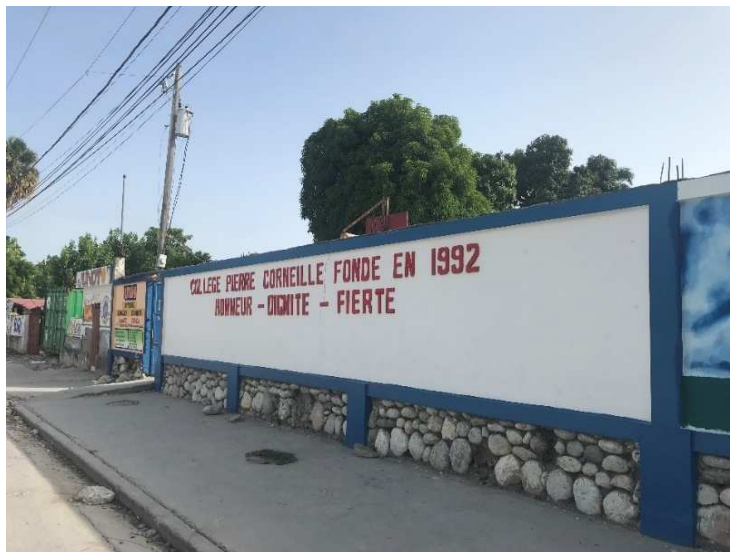
Figure 47 - Building 30

- Damage: This college building extends for a 100m distance perpendicular to the road. For the most part it is free from damage but at the end remote from the road there is evidence of ground movement that has resulted in structural cracking.
- **Recommended restrictions: It is recommended that access into the building is prohibited in the zone of ground settlement and of the associated structural defects.**

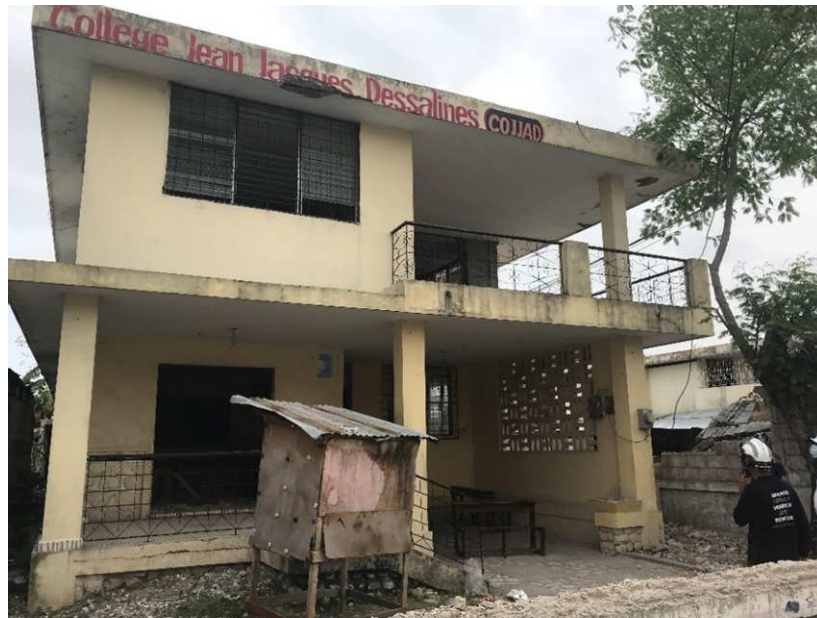
Figure 48 - Building 31

- Damage: The condition of the College building is free from significant damage that would curtail its use.
- Recommended restrictions: None required for the building. However the adjacent boundary wall exhibits significant damage and access around it should be prohibited.

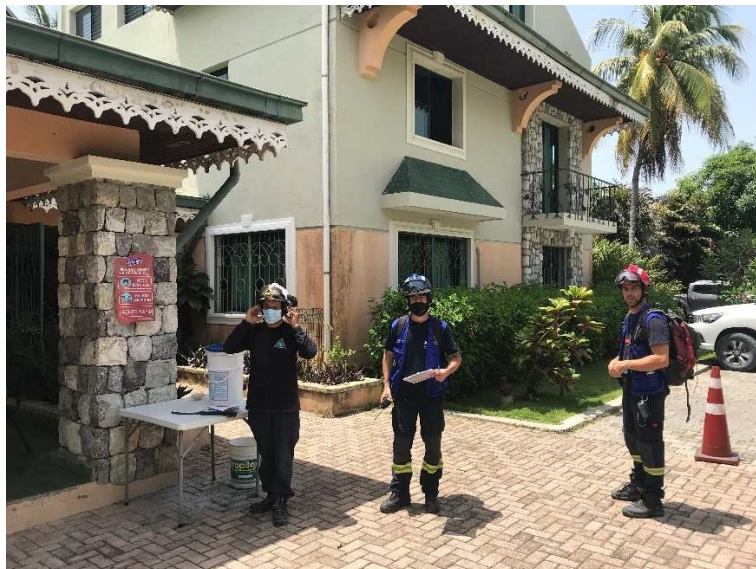
Figure 51 - Building 34

- Damage: Limited nature of identified cracking is not a concern for safety of buildings.
- Recommended restrictions: None required. However, presence of clients' tents close to buildings is risky in case of falling debris during aftershocks and should be prohibited.

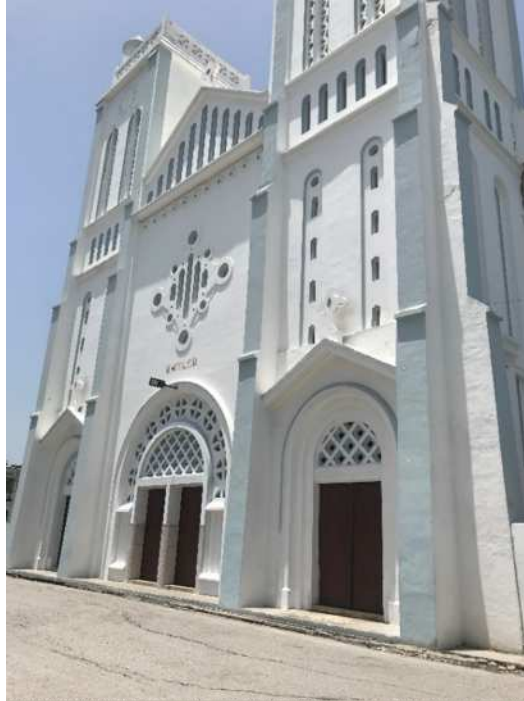
Figure 52 - Building 35

- Damage: The building has been made secure and only external assessment was possible. However evident change of relative levels at street frontage appears to have occurred and requires further investigation.

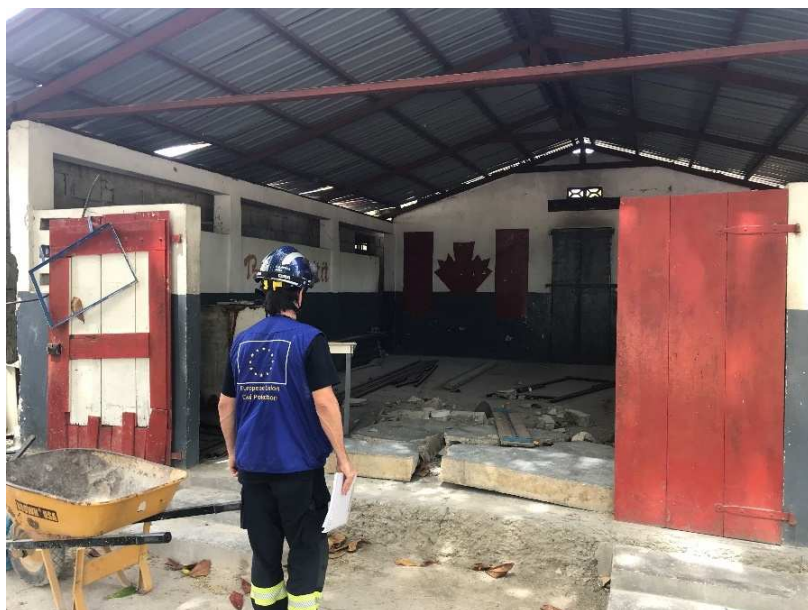
Figure 53 - Building 36

- Damage: The extent of structural damage to this particular facility building is minor.
- **Recommended restrictions:** Continued use is acceptable subject to removal of loose material.

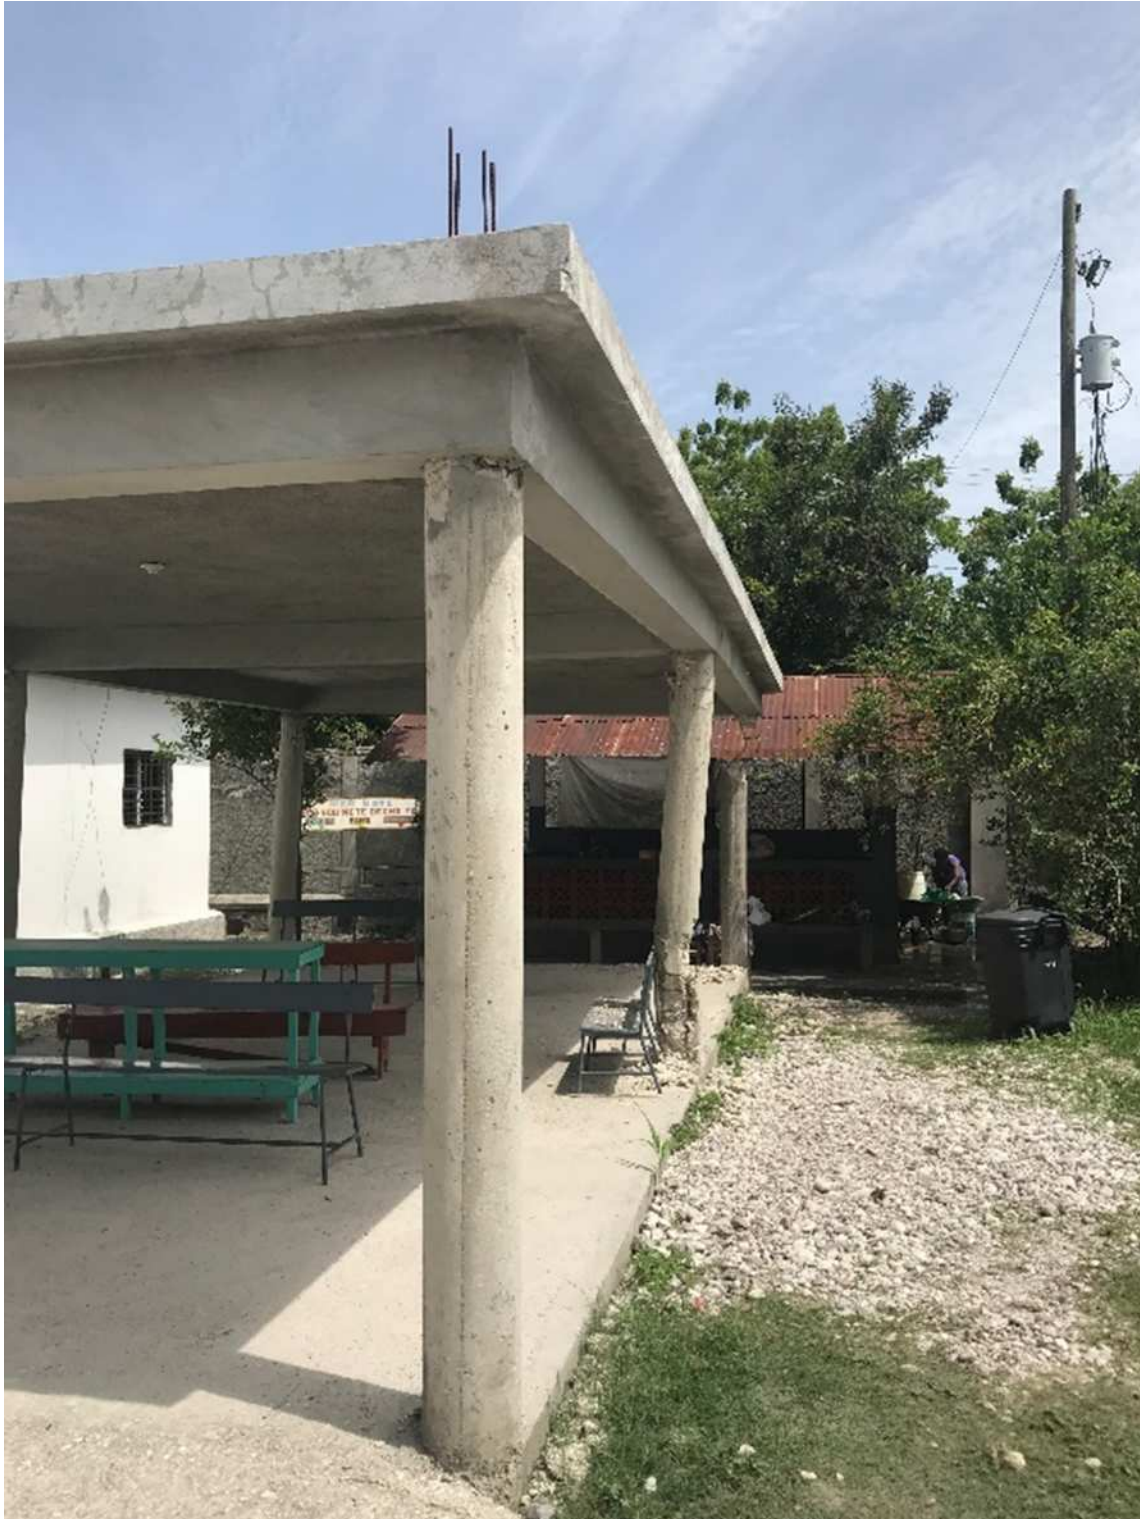
Figure 54 - Building 37

- Damage: The structural failure of column supports exhibits extreme effects of sway frame behaviour. The consequent damage renders this shelter/car port unsafe to use.
- Recommended restrictions: Our recommendation is that the structure is unsafe to use.

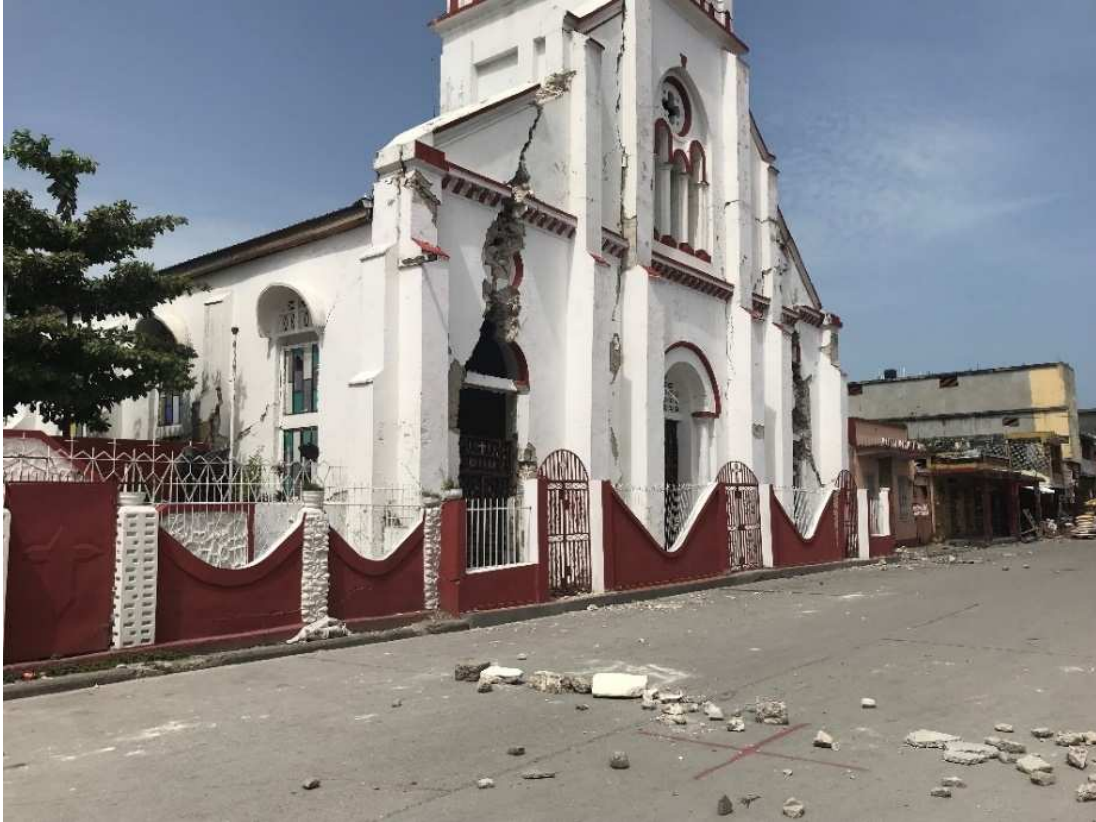
Figure 55 - Building 38

- Damage: Extensive cracking and areas of localised collapse render this building highly unstable.
- Recommended restrictions: Our recommendation is that the structure is unsafe to use. Significant expansion of the existing exclusion zone around it is recommended.

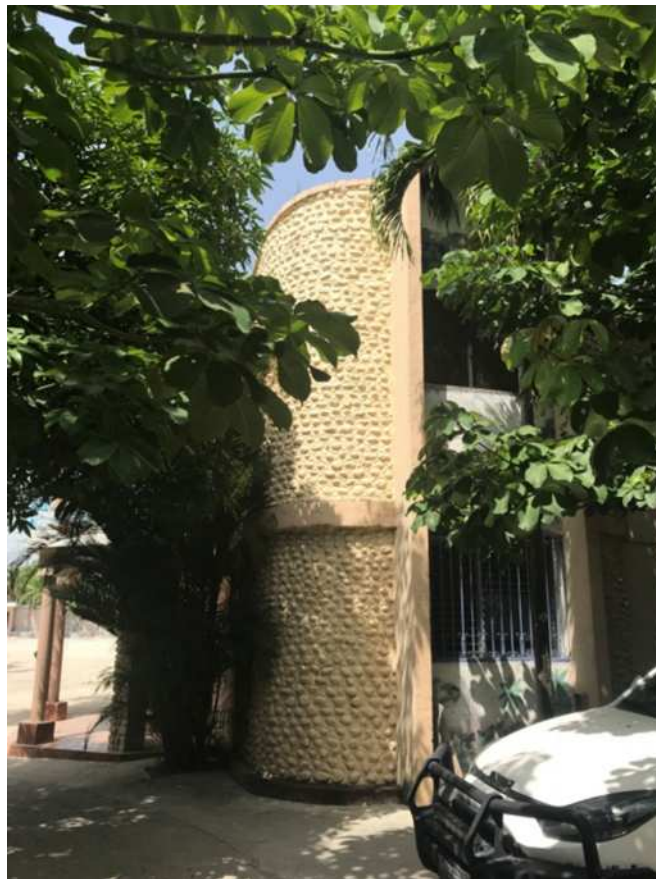
Figure 58 - Building 40

- Damage: The reception building, built at the same time as the now-demolished main block, has suffered minor cracking while uplift and cracking have affected floors at ground level.
- Recommended restrictions: Access to the building to be restricted until a detailed evaluation confirms whether it is safe for use or needs to be evacuated.

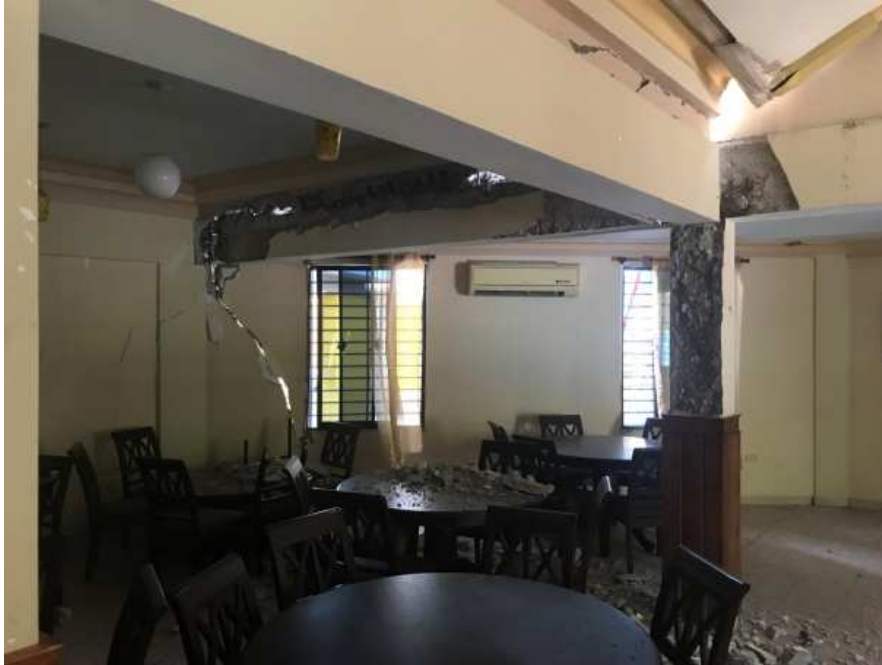
Figure 59 - Building 41

- Damage: The roof over the restaurant has a substantial reinforced concrete structure that has suffered significant damage resulting from the earthquake. This damage is beyond repair.
- Recommended restrictions: Our recommendation is that the structure is unsafe to use.
