SUMMARY OF ADVISORY BUILDING SAFETY ASSESSMENTS BY INTERNATIONAL ENGINEERS FOLLOWING THE AUG 14 M7.2 HAITI EARTHQUAKE

Report compiled by SARAID UK

25th August 2021

This report summarizes the outcome of detailed building safety evaluations of priority buildings in the Les Cayas area following the M7.2 earthquake that struck the Tiburon Peninsula of Southern Haiti on 14th Aug 2021.

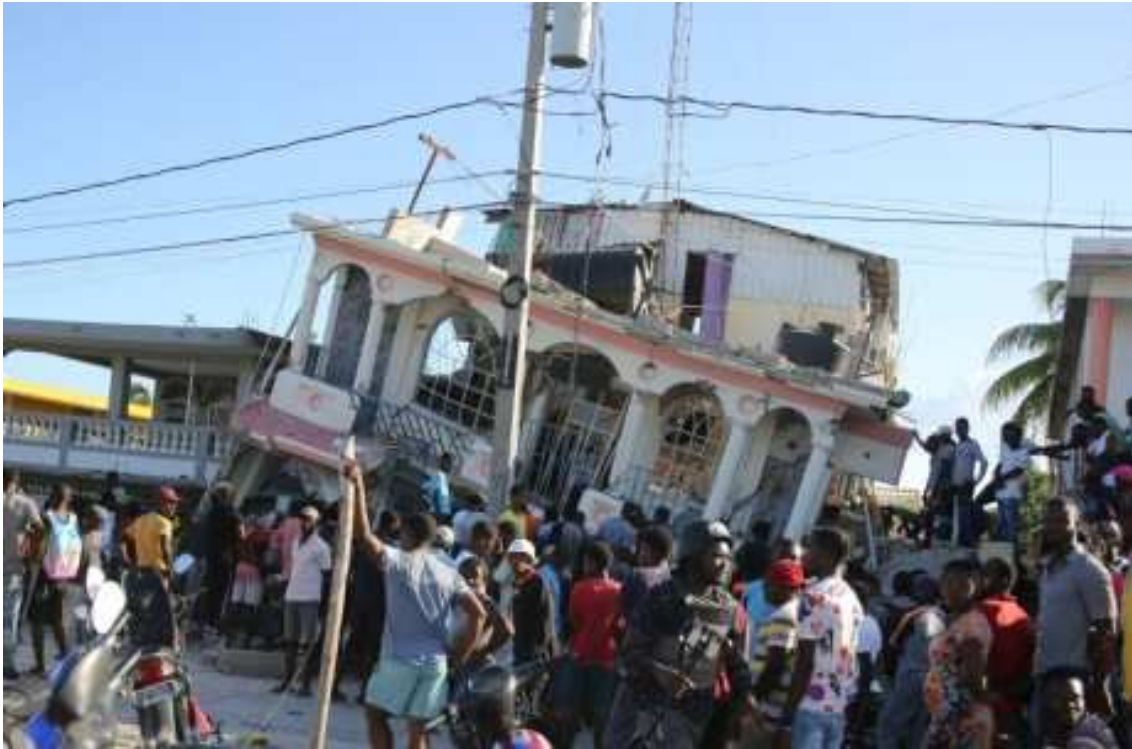
- Damage: The building was destroyed by the earthquake and has subsequently been cleared from the site.

Figure 61 – Building 43 (Photo Credit: Joseph Odelyn, Associated Press)

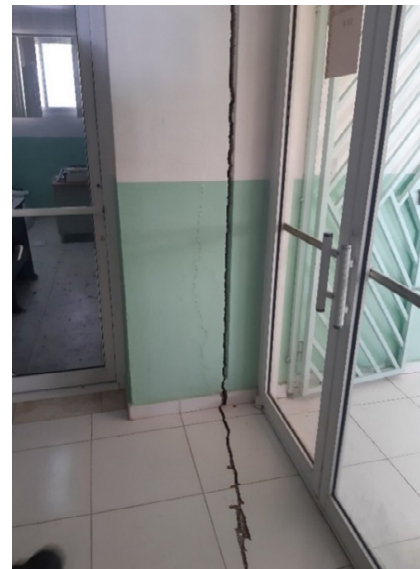
Figure 68 - Movement joint cracking

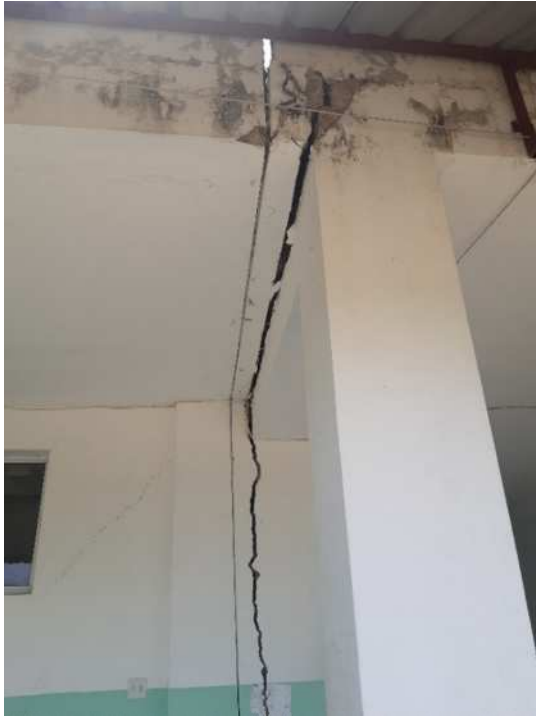
Figure 69 - Movement joint cracking resulting in loose fill

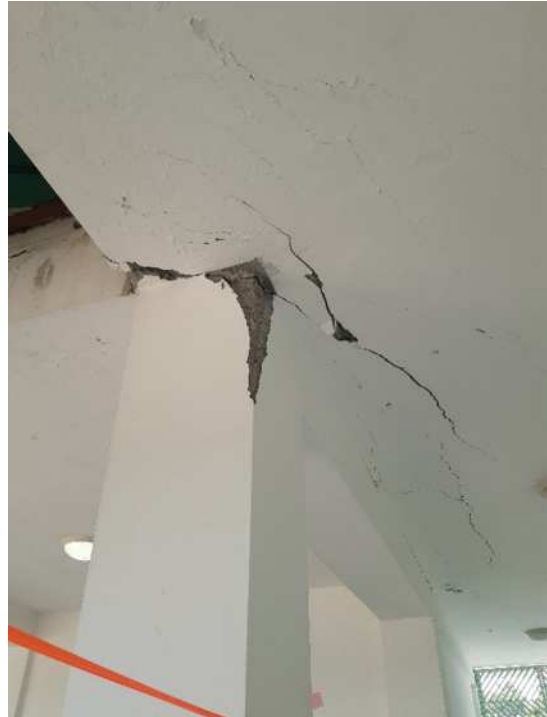
Figure 70 - Cracking around the column head and slab

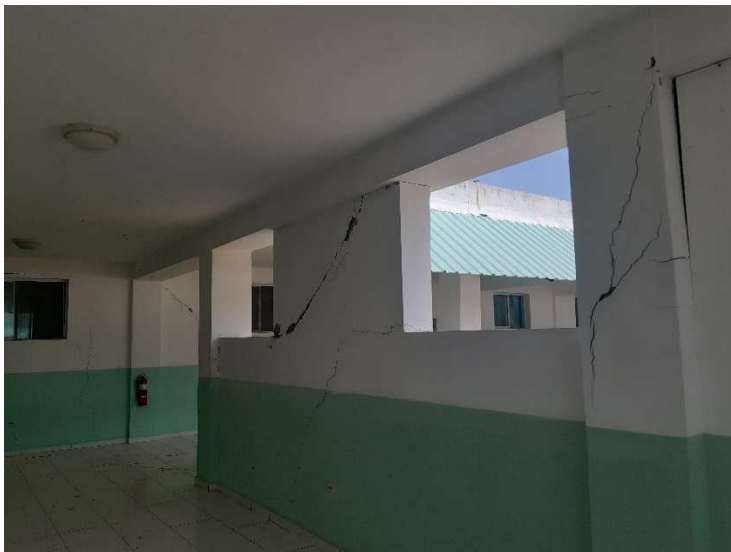
Figure 71 - Column cracking and short column shear crack

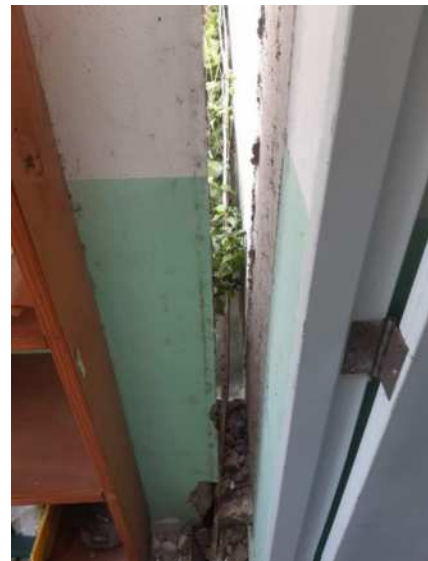
Figure 72 - Subsided extension
