SUMMARY OF ADVISORY BUILDING SAFETY ASSESSMENTS BY INTERNATIONAL ENGINEERS FOLLOWING THE AUG 14 M7.2 HAITI EARTHQUAKE

Report compiled by SARAID UK

25th August 2021

This report summarizes the outcome of detailed building safety evaluations of priority buildings in the Les Cayas area following the M7.2 earthquake that struck the Tiburon Peninsula of Southern Haiti on 14th Aug 2021.

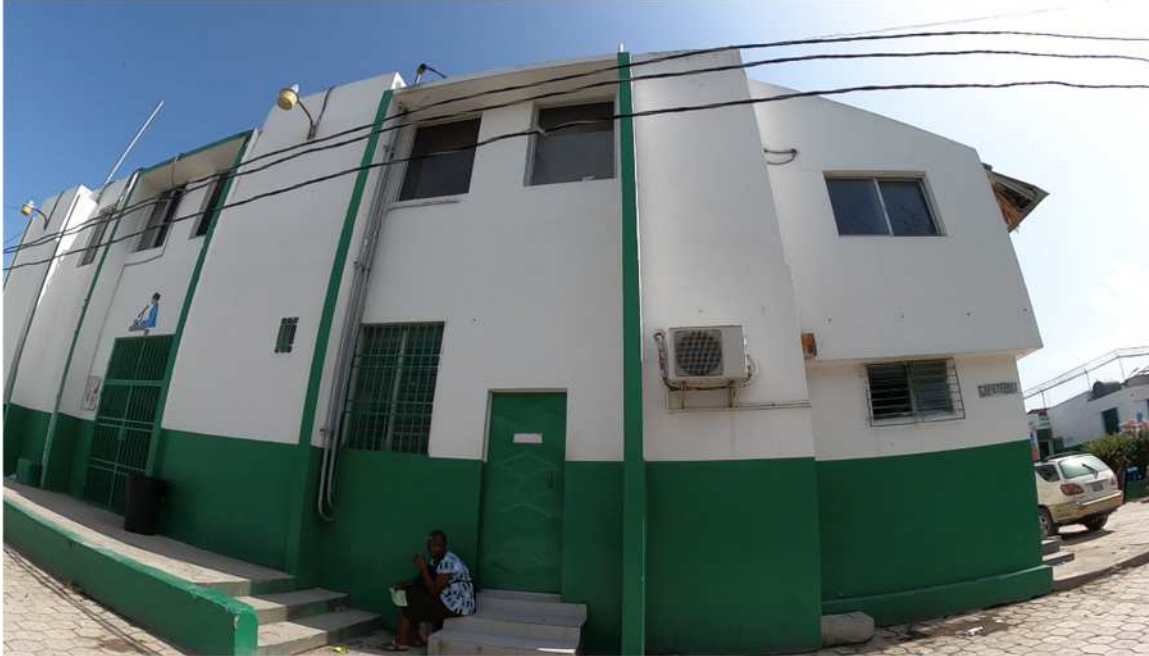
Figure 18 - Building 8

- Damage: This building had no damage that was identified during the assessment
- Assessment constraints: Only the outside of the structure was inspected as we could not gain access
- **Recommended restrictions: None required**

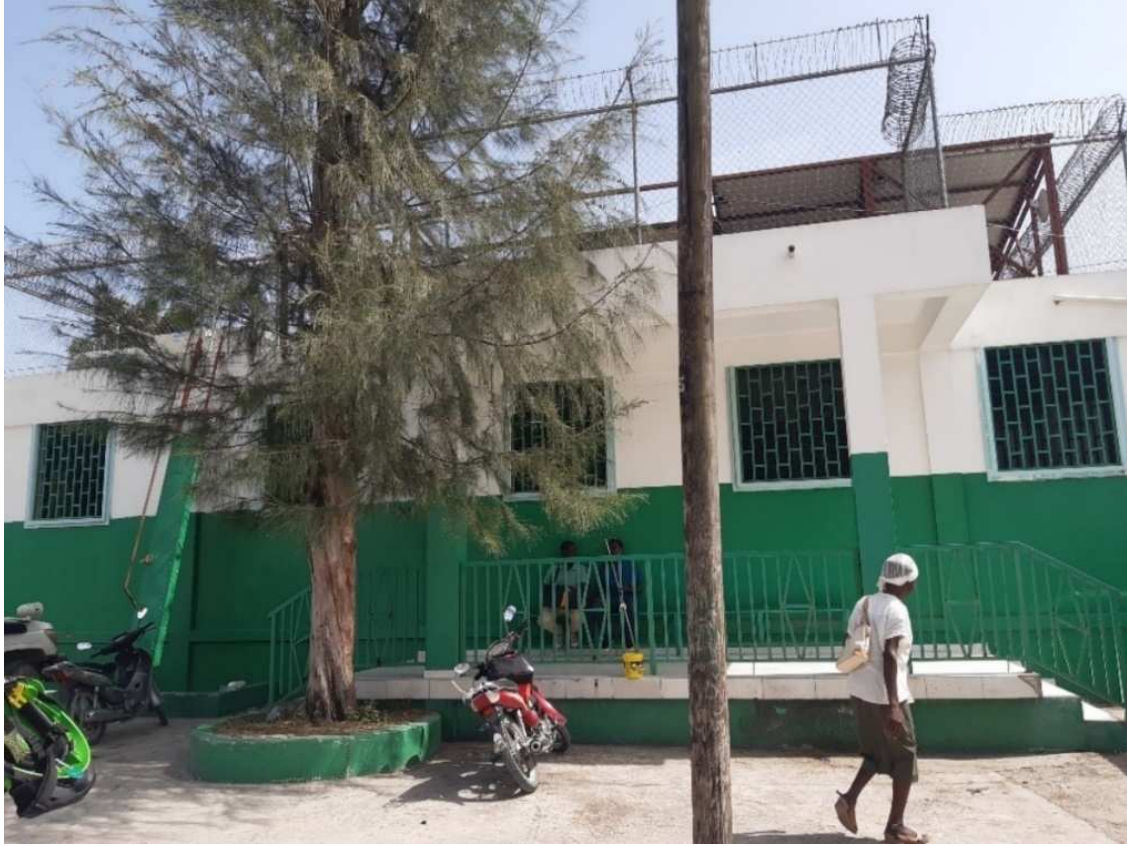
Figure 19 - Building 9

- Damage: There was some mold to one of the ceilings however no structural damage was identified during the assessment
- **Recommended restrictions: None required**

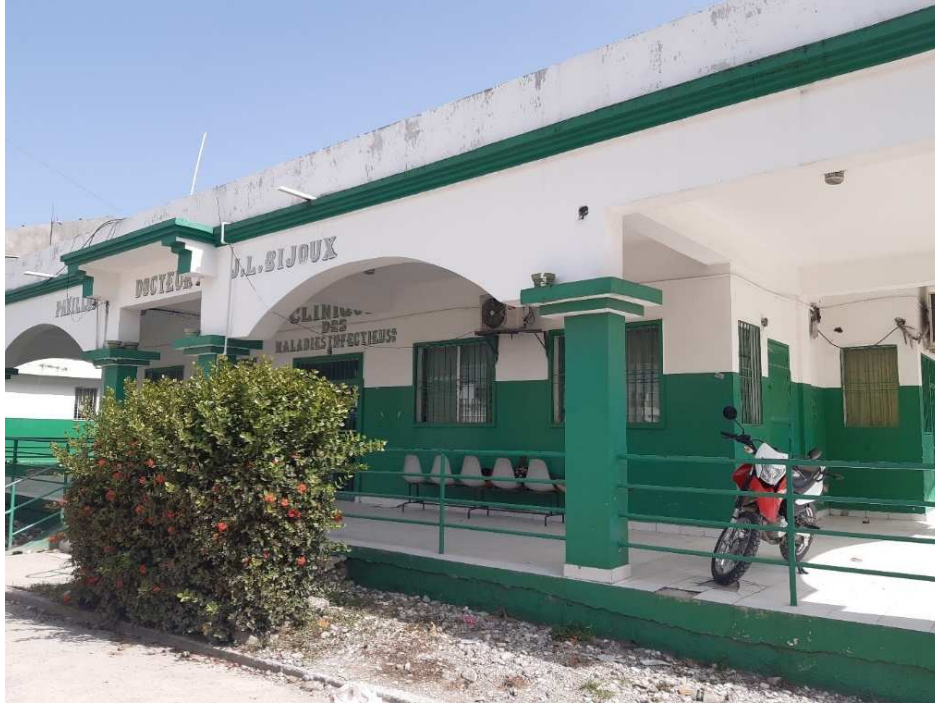
Figure 24 -Building 12

- Damage: This building had no damage that was identified during the assessment
- Assessment constraints: Only the outside of the structure was inspected as we could not gain access
- Recommended restrictions: None required

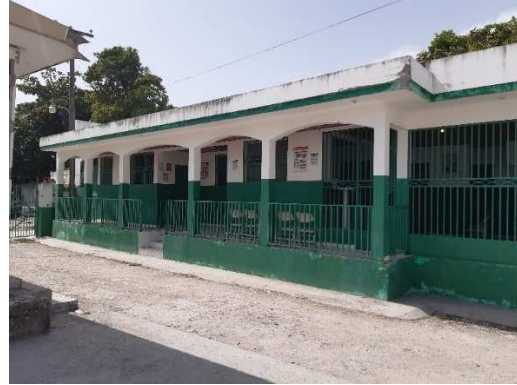
- Damage: The supporting structure to the edge of the entrance overhang was cracked and leaning, see Figure 27.
- Assessment constraints: The area shown in Figure 26 was not accessed.
- **Recommended restrictions:** We advise that the area under the right-hand side of the portico (when looking at the building, Figure 27) should be restricted.

Figure 26 - Area of building 13 that could not be accessed

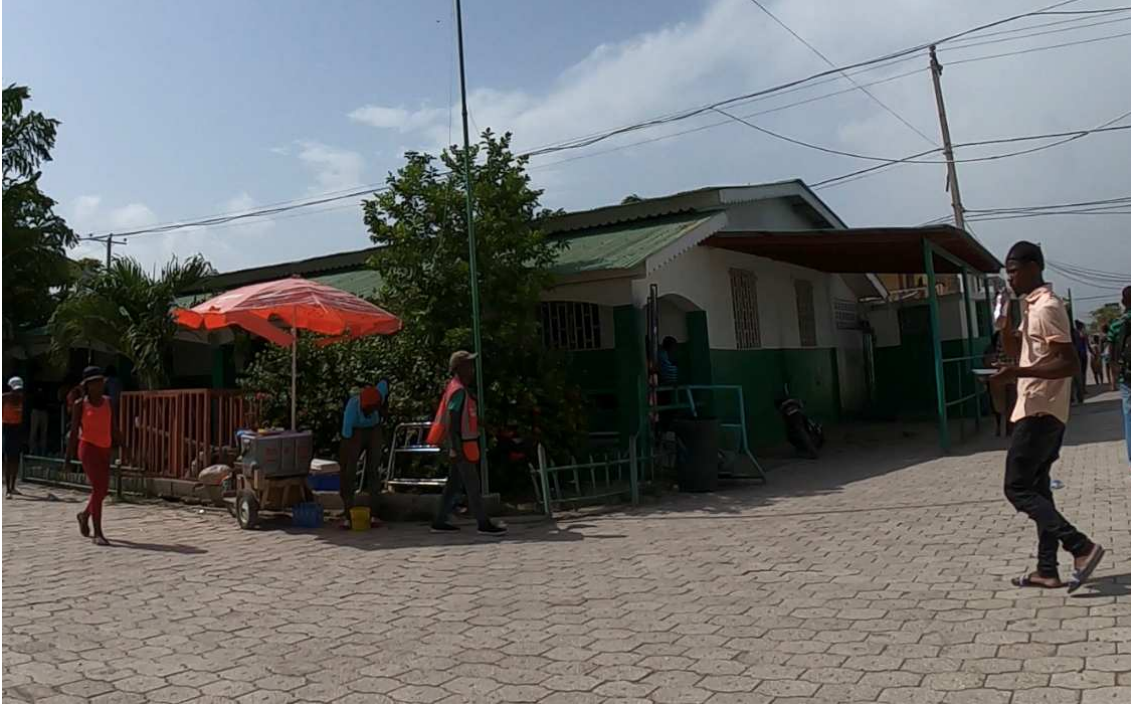
Figure 28 - Building 14

- Damage: This building had no damage that was identified during the assessment
- Assessment constraints: Only the outside of the structure was inspected as we could not gain access
- **Recommended restrictions: None required**

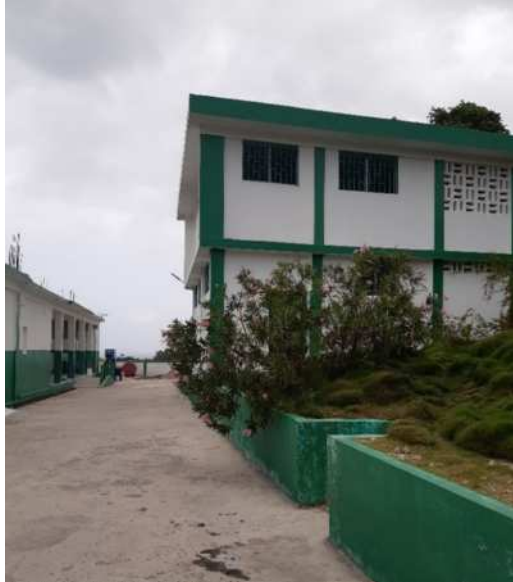
Figure 31 - Building 16

- Damage: This building had no damage that was identified during the assessment
- Assessment constraints: Only the outside of the structure was inspected as we could not gain access
- **Recommended restrictions: None required**

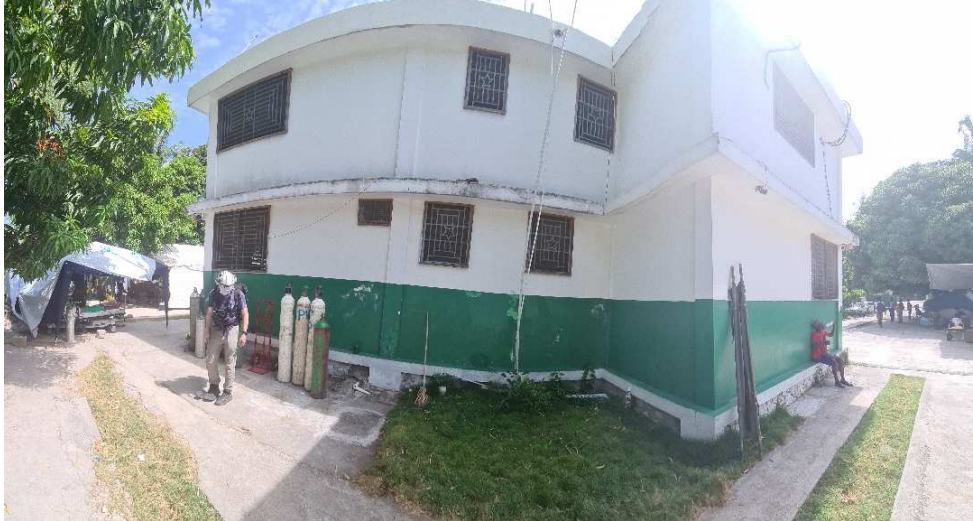
Figure 32 - Building 18

- Damage: This building had no structural damage that was identified during the assessment
- **Recommended restrictions: None required**

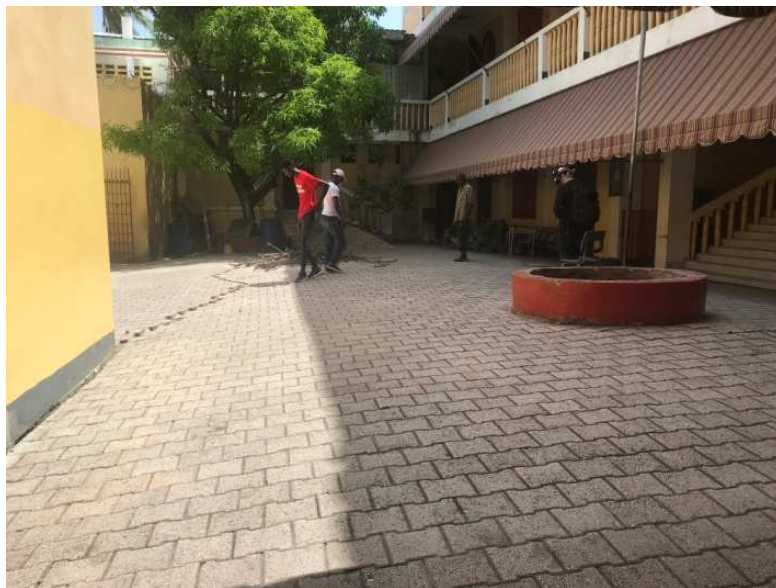
Figure 37 - Building 21 courtyard heave

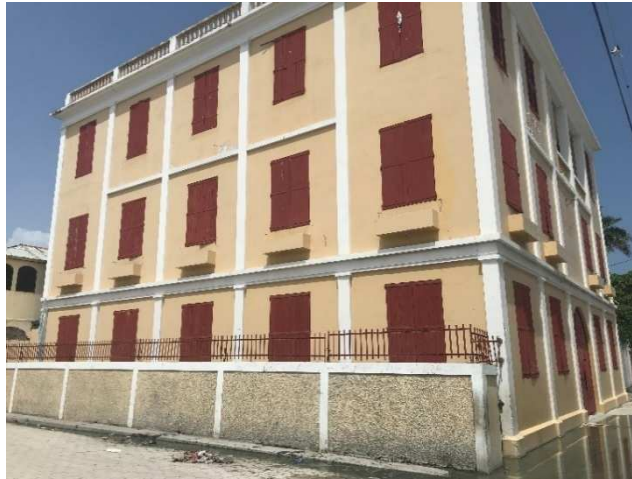
Figure 40 - Building 23

- Damage: Inspection of the building externally and from within did not reveal structurally significant damage. The condition of this classroom block permits continued use. - There is some limited evidence of downward displacement relative to the adjacent street which has resulted in some ponding of surface water.
- **Recommended restrictions: None required.**

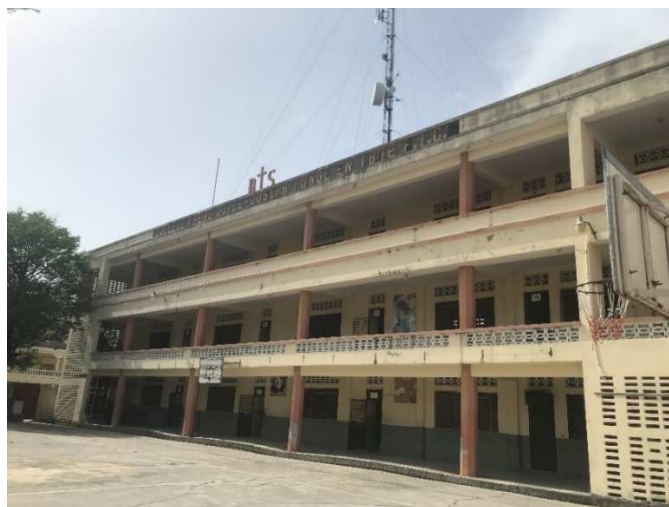
Figure 43 - Building 26

- Damage: The classroom block does not exhibit any significant structural that would limit its use.
- Recommended restrictions: None required.

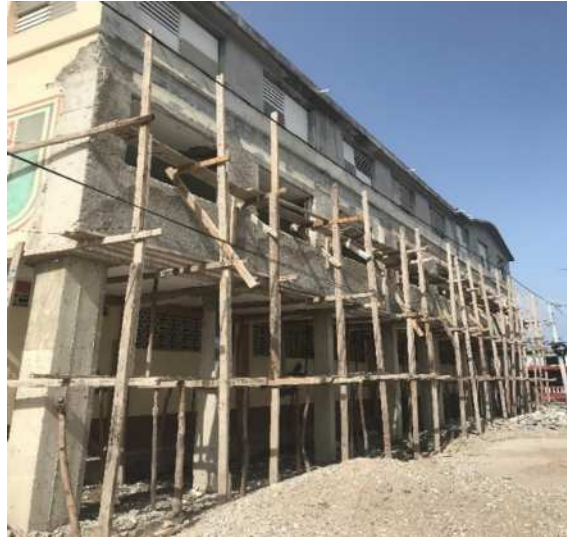
Figure 44 - Building 27

- Damage: There are instances of minor cracking around stairs and on the ground floor but these are not structurally significant. The recent development of the building above the adjacent pavement area exhibits no ill-effects of seismic effects.
- Recommended restrictions: None required.

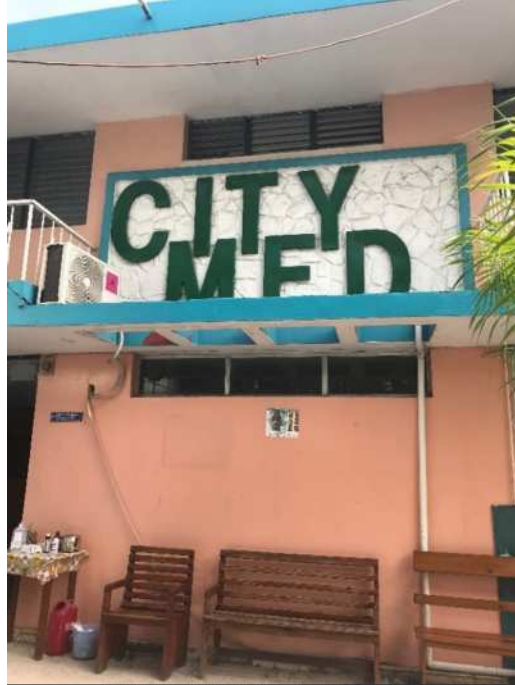
Figure 46 - Building 29

- Damage: External examination of this clinic showed no signs of damage.
- **Recommended restrictions: None required**

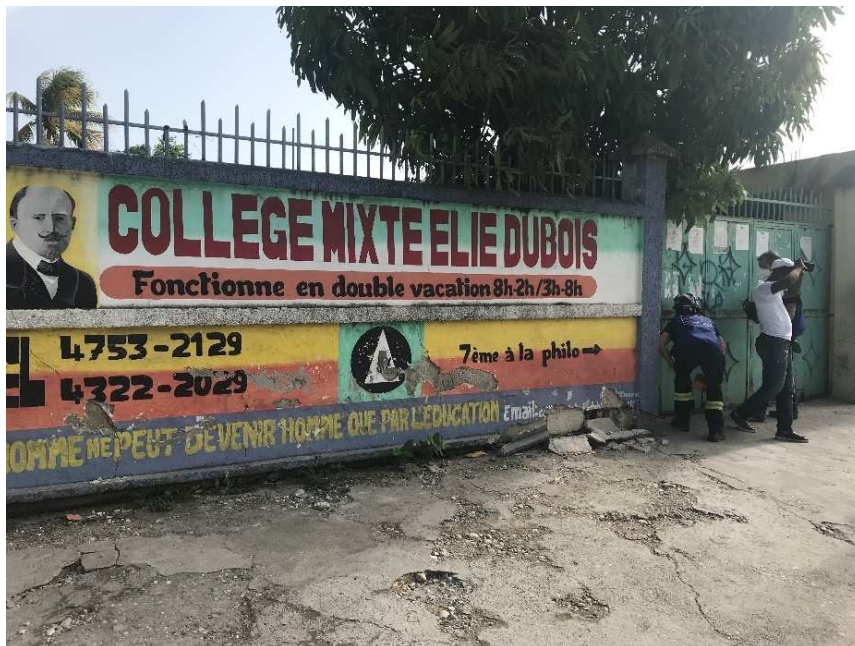
Figure 49 - Building 32

- Damage: Access for inspection was limited but sufficient external viewing was made to enable recommendation unrestricted use of the college building.
- Recommended restrictions: None required.

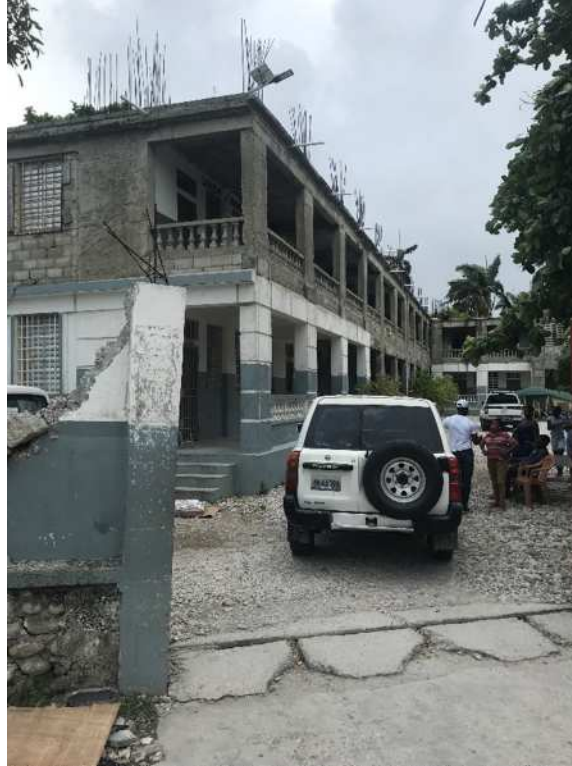
Figure 50 - Building 33

- Damage: No visible damage was discernible for this particularly robust construction.
- Recommended restrictions: None required.

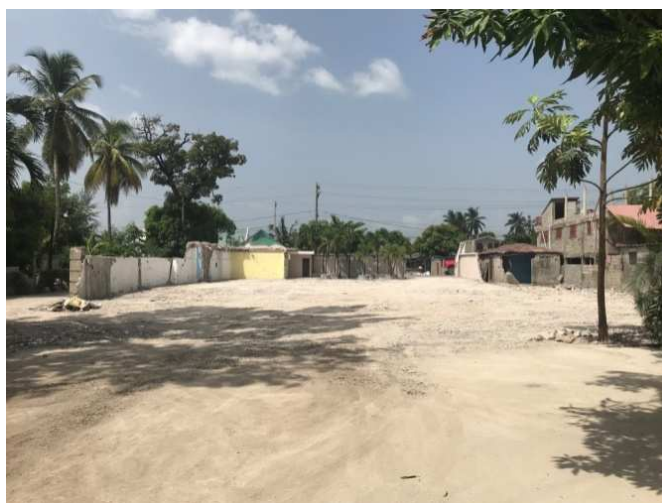
The major 4-storey building structure that had been constructed approx 10 years ago has been demolished and cleared from site shortly after the 2021 earthquake event.

Figure 56 - Building 39 - destroyed by earthquake and subsequently cleared from site

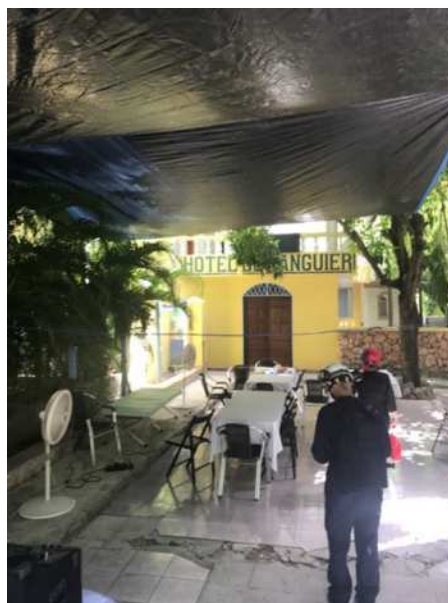
Figure 60 – Building 42

- Damage: The recently constructed extension to hotel exhibits negligible damage and remains in usable condition.
- Recommended restrictions: None required.

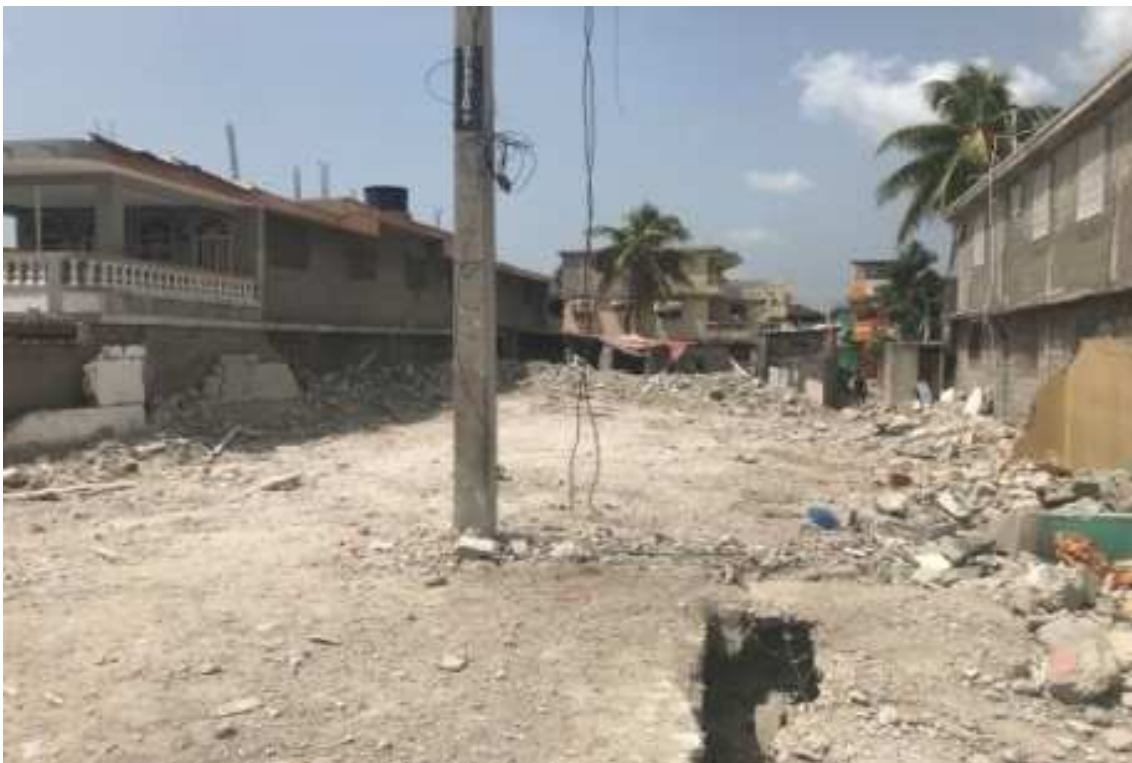
Figure 62 – Building 43 – Site cleared

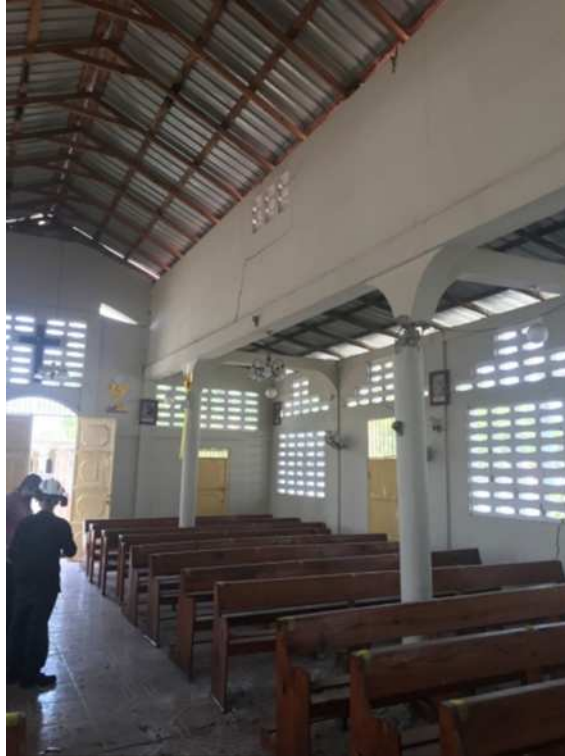
Figure 63 - Building 44

- Damage: The central column that supports the east side of the roof has lost its structural integrity and the deep spanning beam above has developed a shear crack.
- Recommended restrictions: Access to the building to be restricted and **people should be excluded from the area on the east side of the central aisle.**

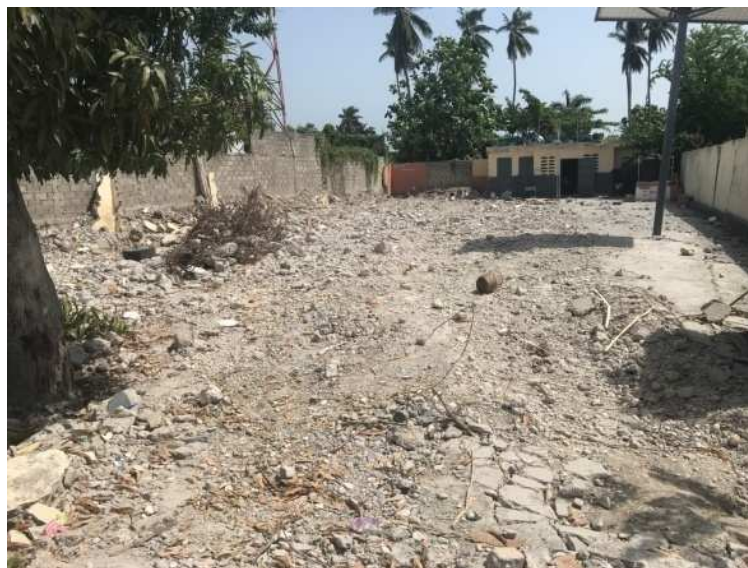
Figure 64 - Building 45

- Damage: The collapsed building that was adjacent to the St Therese church has been cleared.

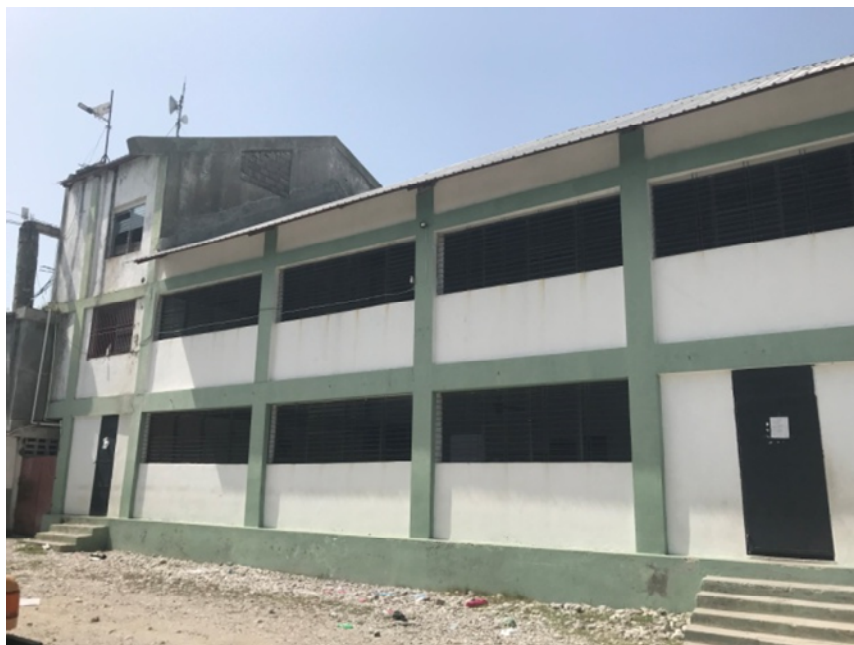
Figure 65 - Building 46

- Damage: The building shows no external signs of significant damage.
- Assessment constraints: The large and recently built church on the school site was inaccessible for assessment.
- Recommended restrictions: None required.

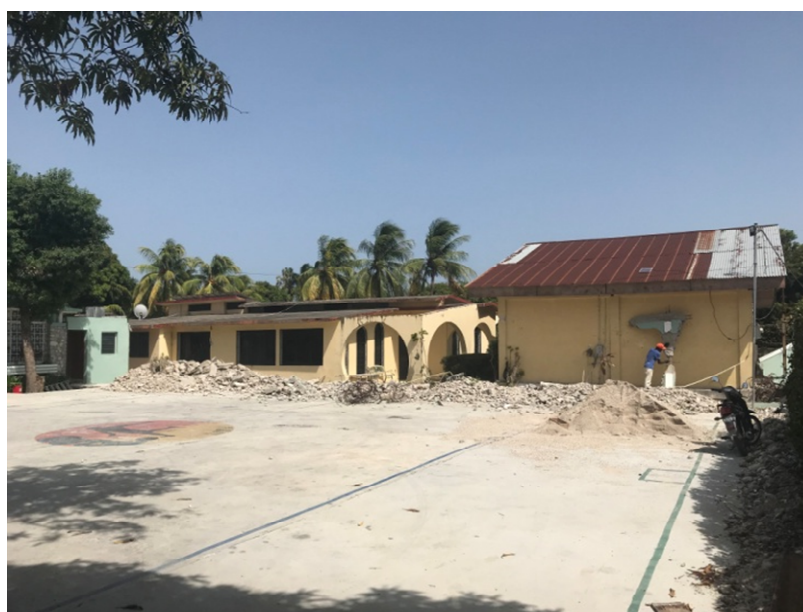
Figure 66 - Building 47

- Damage: The ancillary building that bordered the school's recreation area has collapsed completely. No further visible damage observed.
- Recommended restrictions: None required.

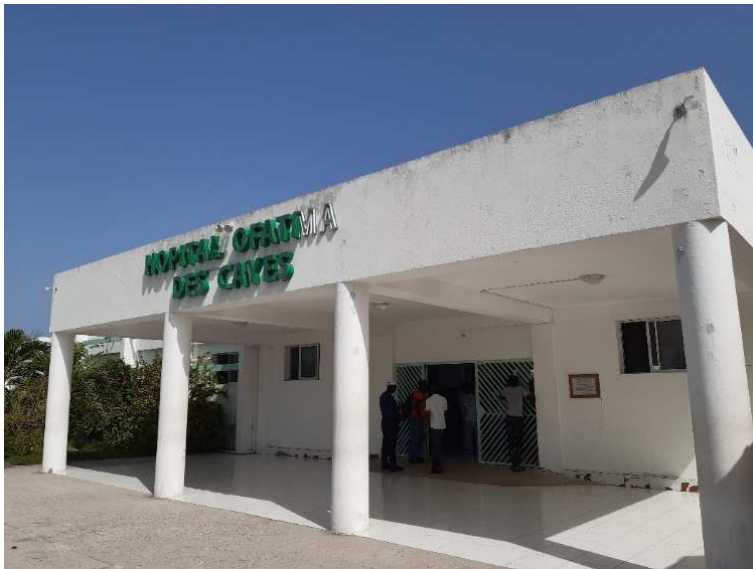
Figure 67 - Building 48

- o A column on the left wing had some cracks on it that appeared on both sides (see Figure 71). It was unclear if this was just to the plaster however it was agreed there's a risk this could be structural damage. A small extension had subsided.

- **Recommended restrictions: External corridor to the left as you walk from reception to the courtyard (with cracking on the ceiling) should be cordoned off. The external corridor with the damaged column to be cordoned off. Extension that has subsided to be cordoned off.**
